Galveston Bay Habitat Restoration

GALVESTON BAY
FOUNDATION

What is Habitat Restoration?

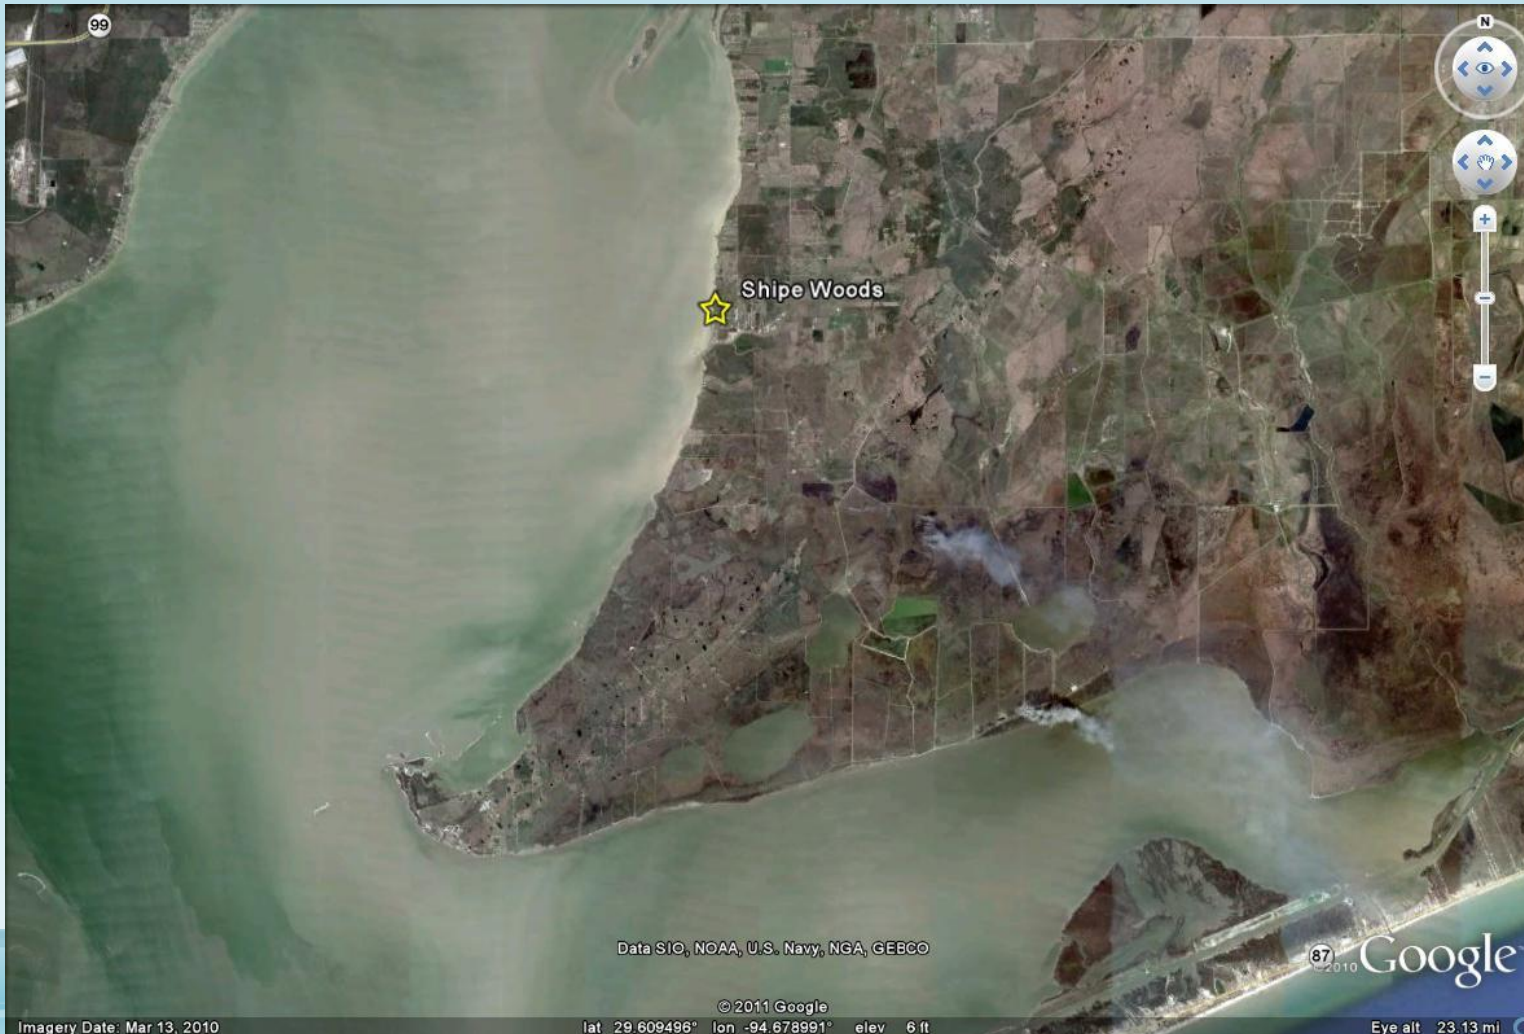
Shipe Woods Habitat Protection and Marsh Restoration

Shipe Woods: 14 acre GBF conservation property

Shoreline faced major erosion issues, losing ~2 acres of property between the 1960's and 2013

In 2013 completed a shoreline protection project to stop/reduce erosion.

Sediment was allowed to accrete behind the breakwater structure and wetland grasses planted as elevations allowed.

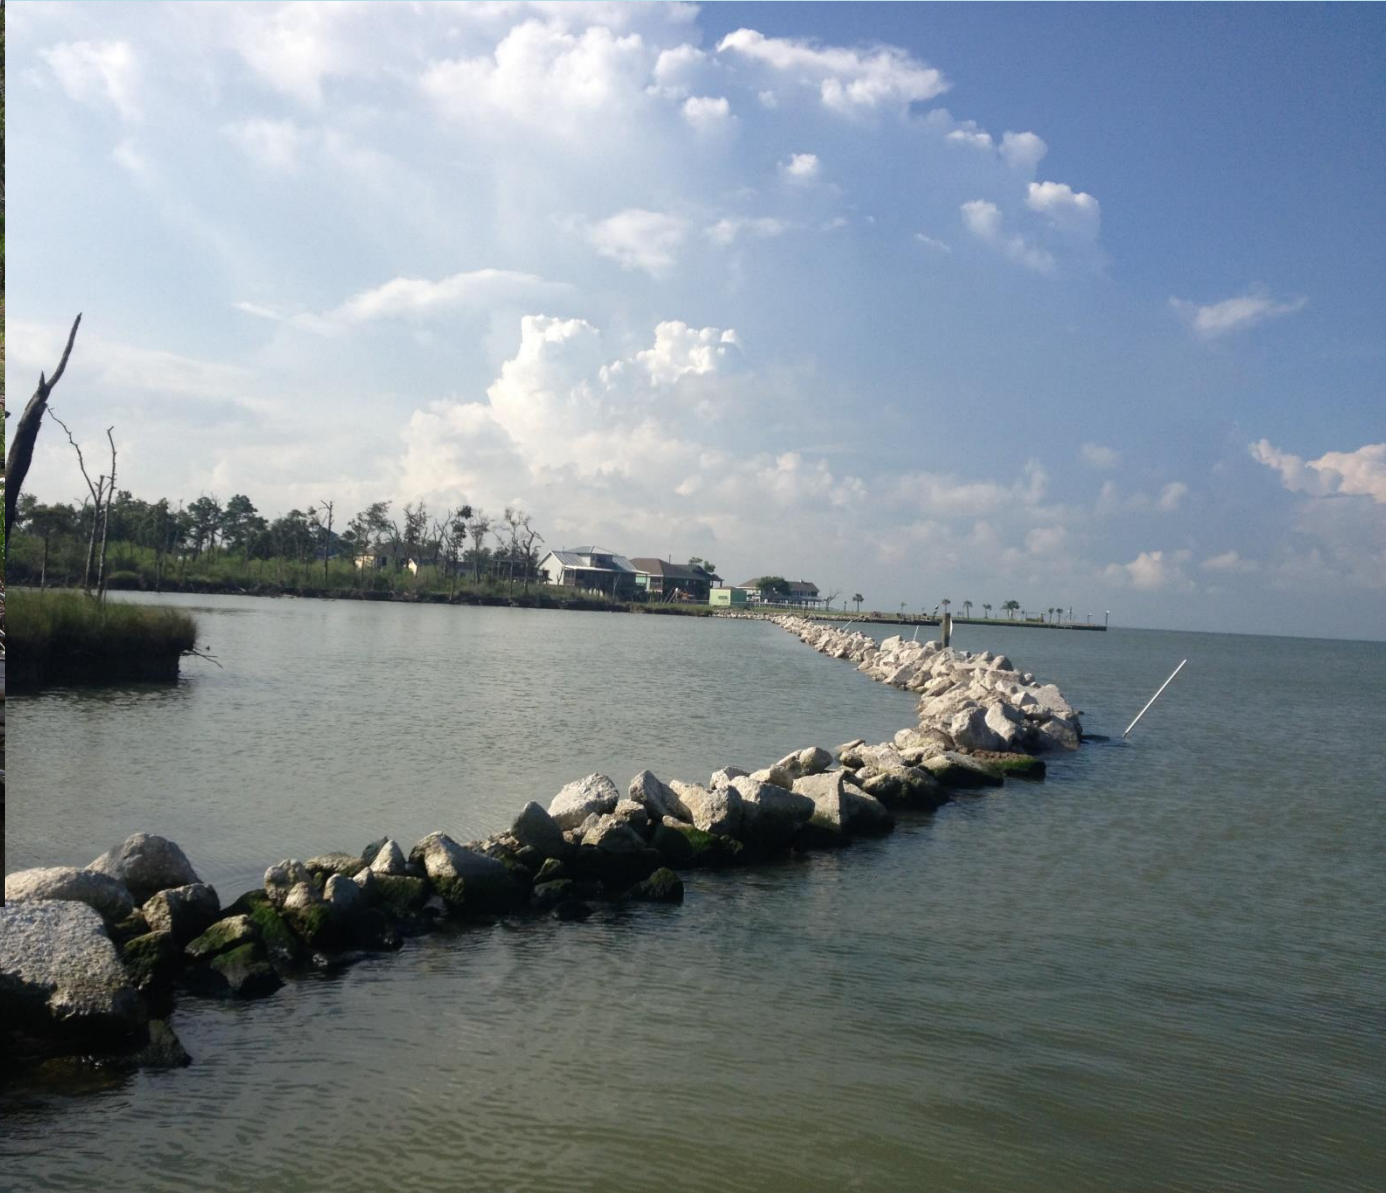
Shipe Woods – 2013 Breakwater Construction

Note: Although present, submerged aquatic vegetation was not mapped in Christmas Bay and Trinity Bay locations in 1956. The 1987 distribution of SAV in these locations is shown for comparison.

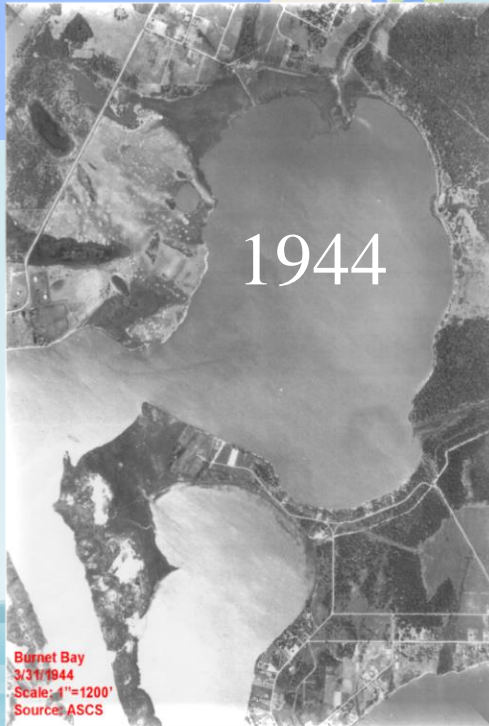
Burnet Bay
3/31/1944
Scale: 1"=1200'
Source: ASCS

Goal: Restore intertidal wetlands within the heavily subsided (8'-10') area of Burnet Bay

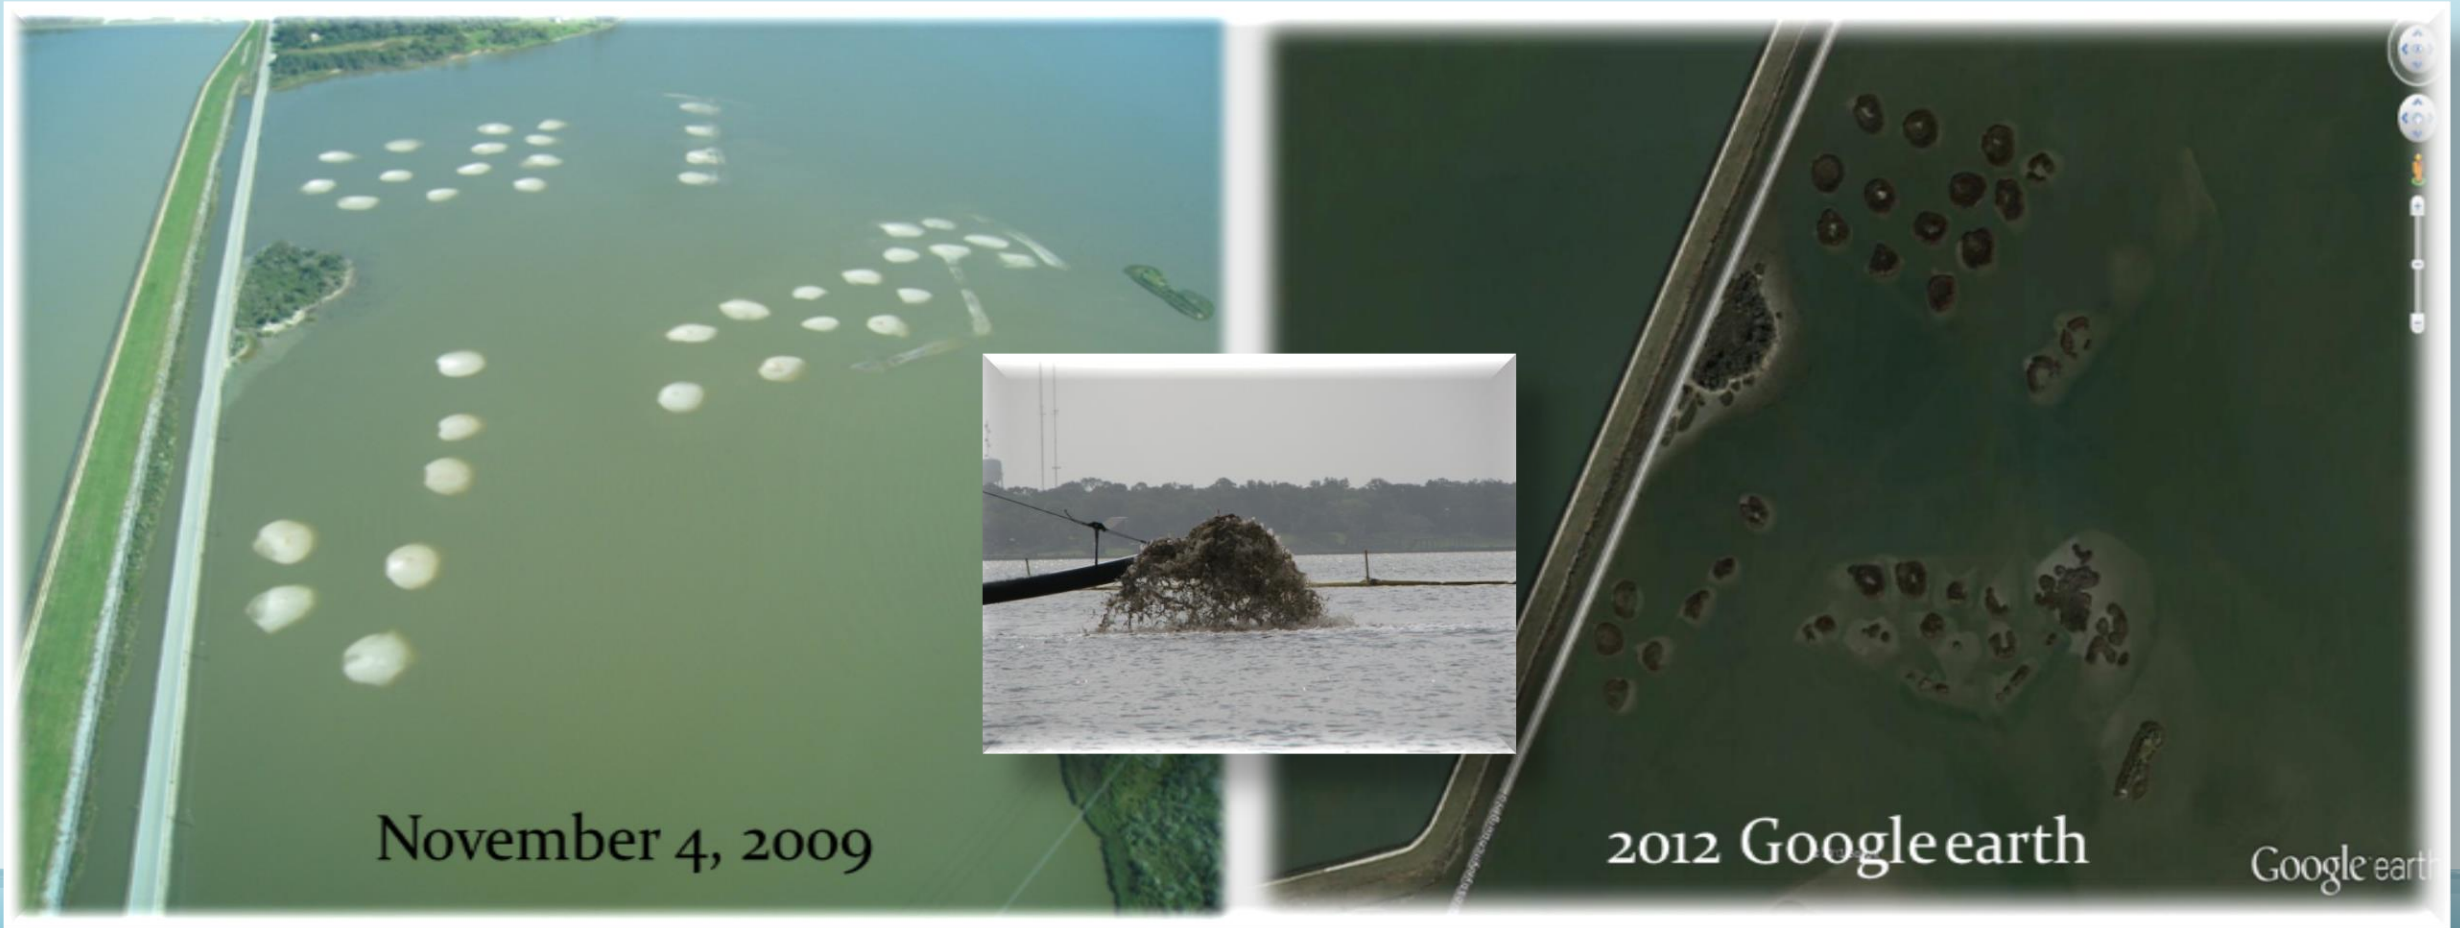
Burnet Bay Wetlands Restoration Phase 1

39 mounds

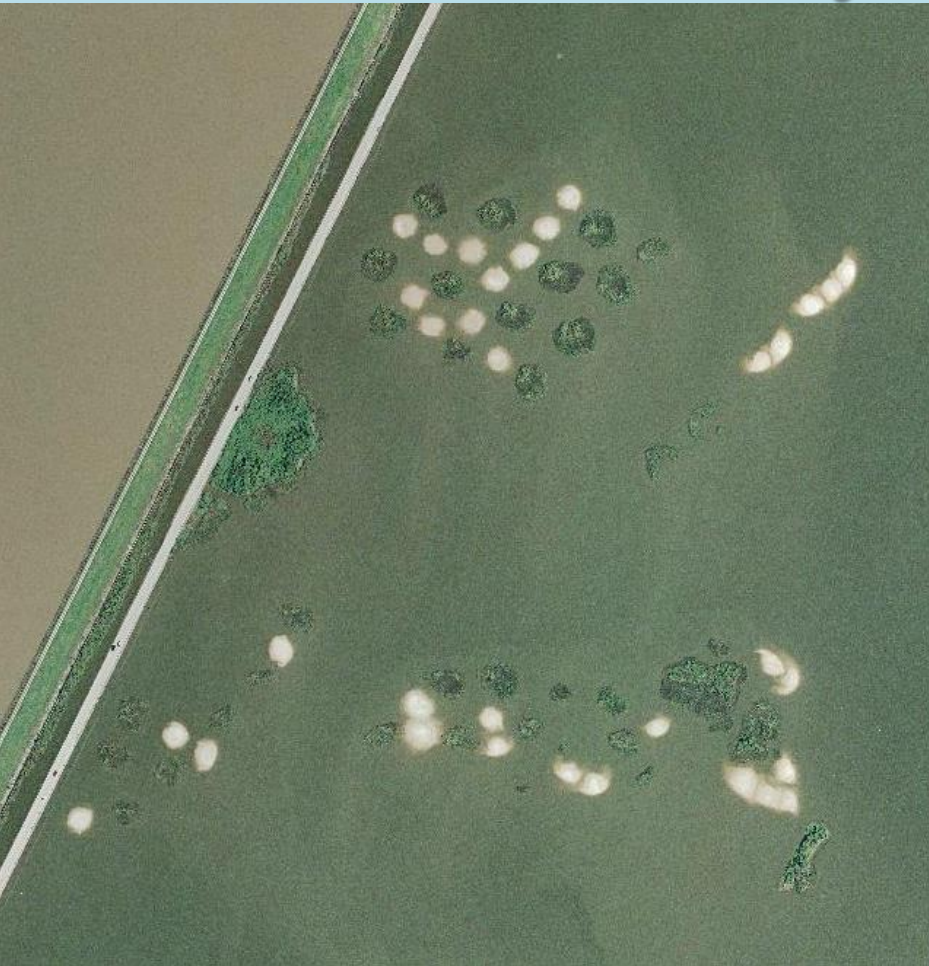
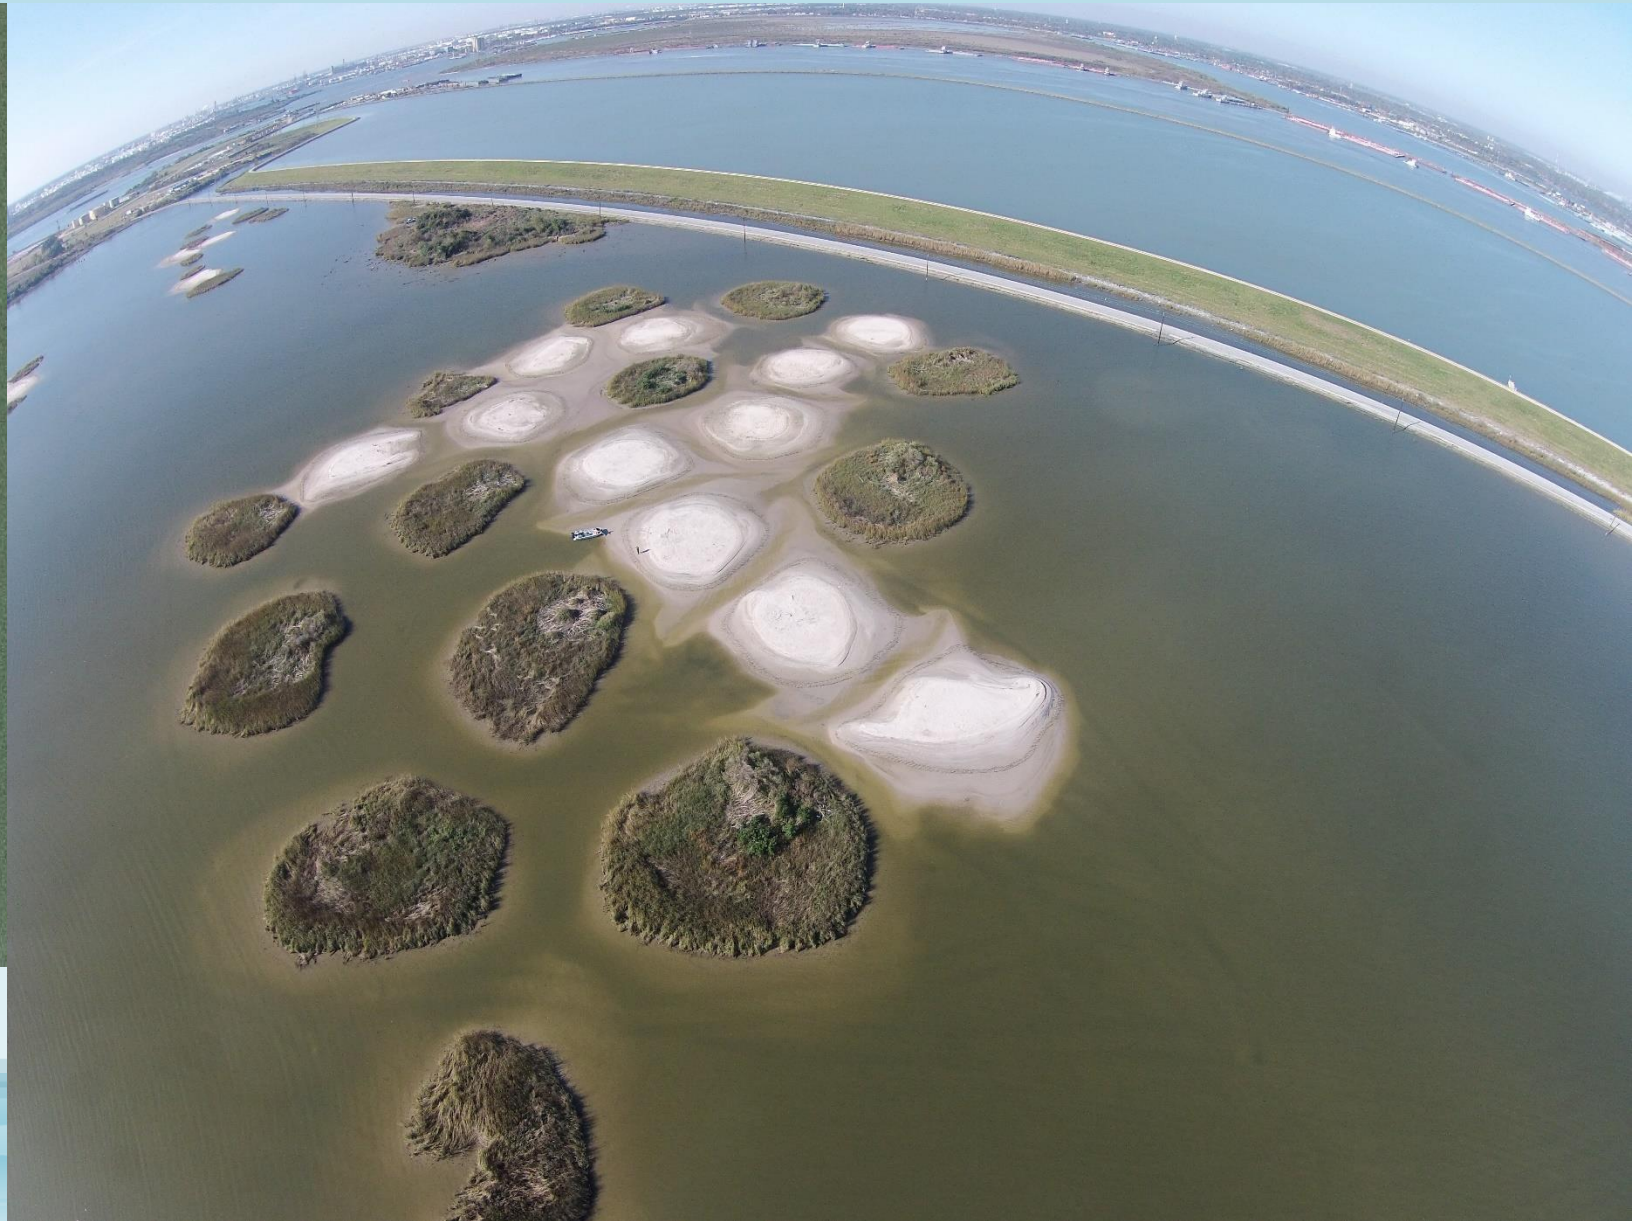
Burnet Bay Wetlands Restoration Phase 2

- Completed Fall 2016 (33 mounds)
- Planted in December 2016

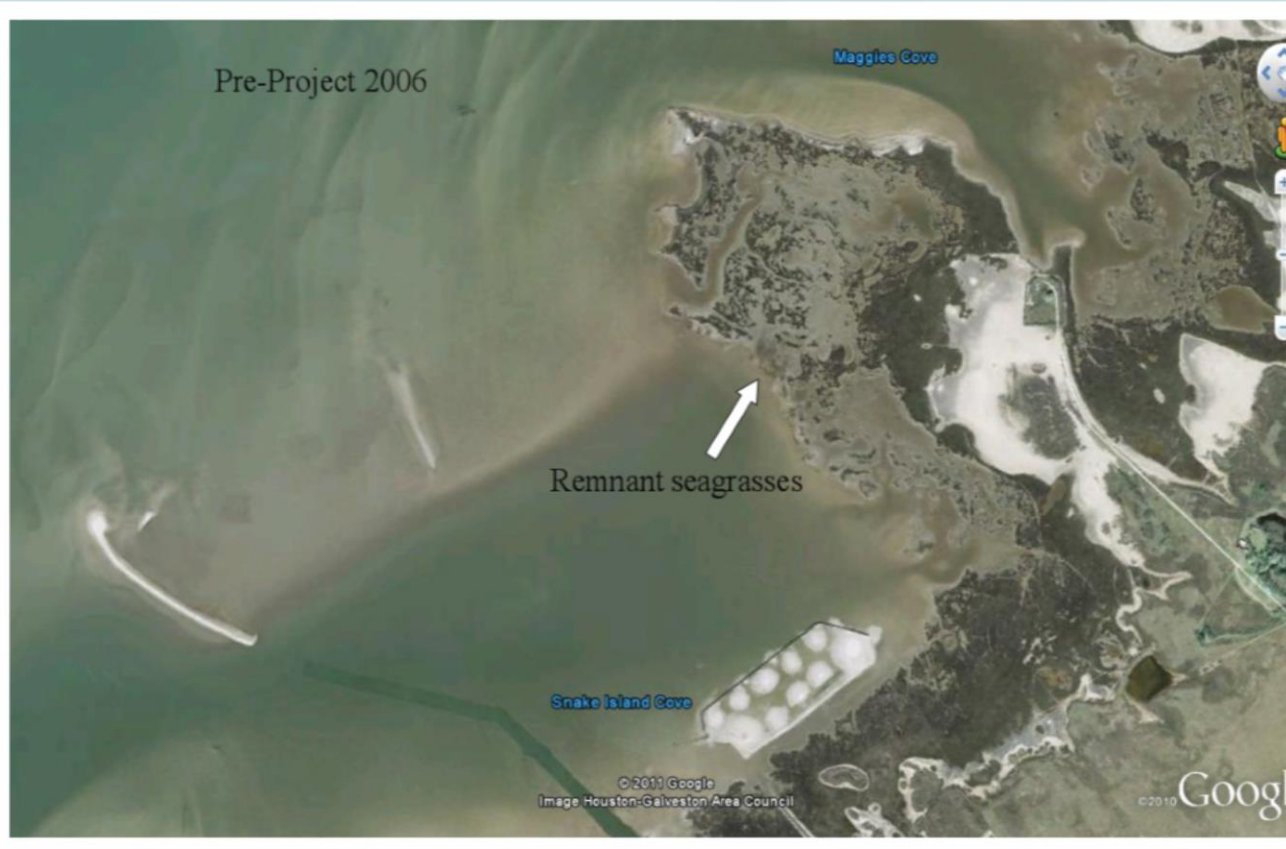
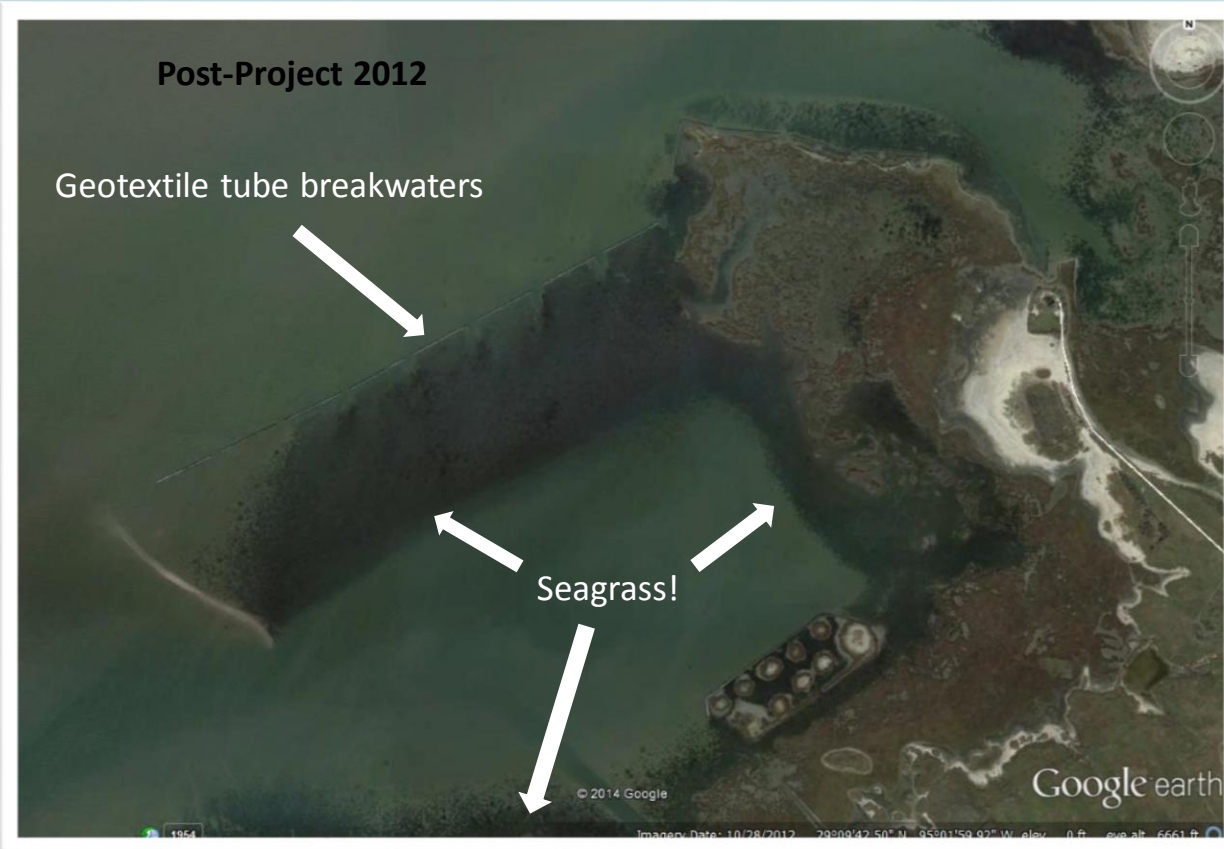
Snake Island Cove

Completed in 2007

Design concept inspired by a TPWD project in the late 1990's at Galveston Island State Park
