Contact Recreation Use Attainability Analysis Pilot Study for Mill Creek Austin County, Texas

PBS&J Project No. 461409.00
Document No. 07H033

**FINAL REPORT
CONTACT RECREATION
USE ATTAINABILITY ANALYSIS PILOT
STUDY
FOR MILL CREEK,
AUSTIN COUNTY, TEXAS
HOUSTON-GALVESTON AREA COUNCIL**

August 2007

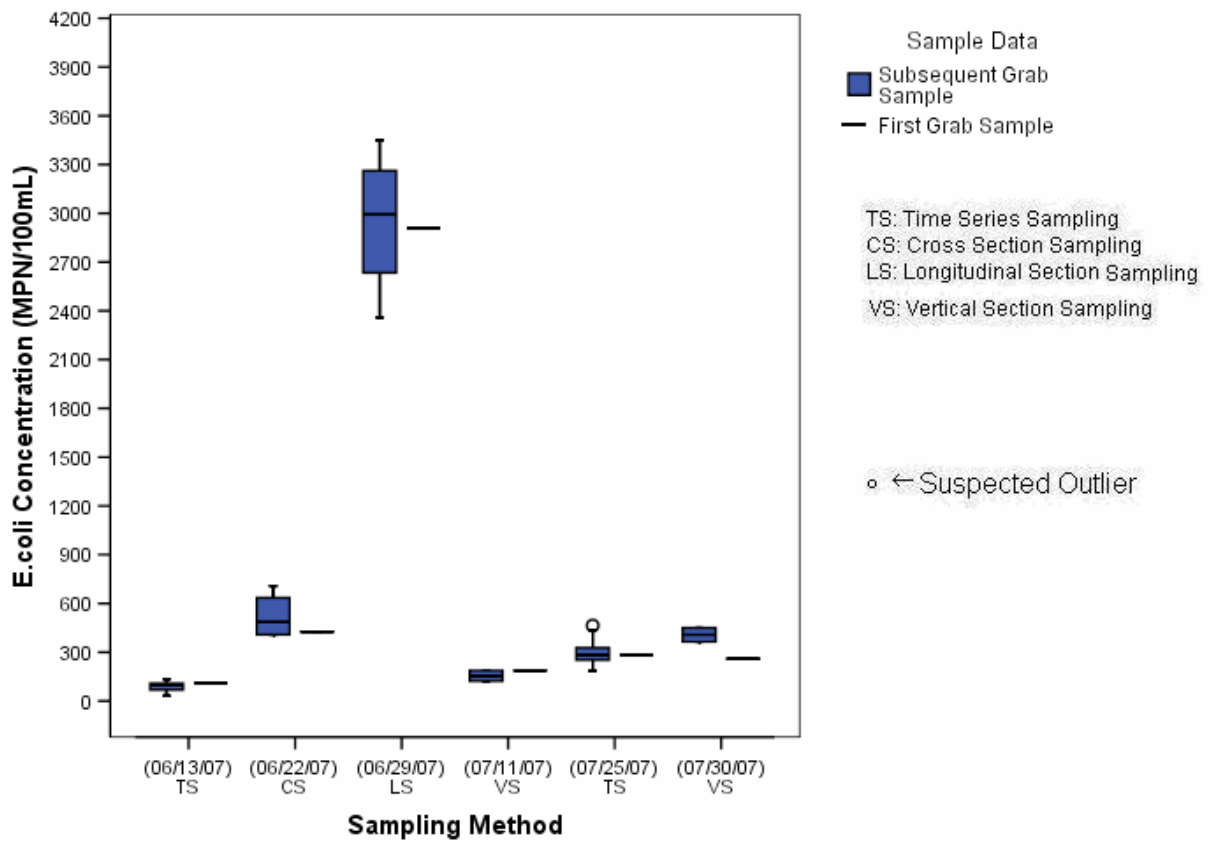
Figure 4-5
Boxplots Comparing the First Grab Sample vs. Entire Sample Set
for *E. coli* Concentration Collected from Six Sampling Events
at Site UAA-2 (Main Stem) During June and July 2007

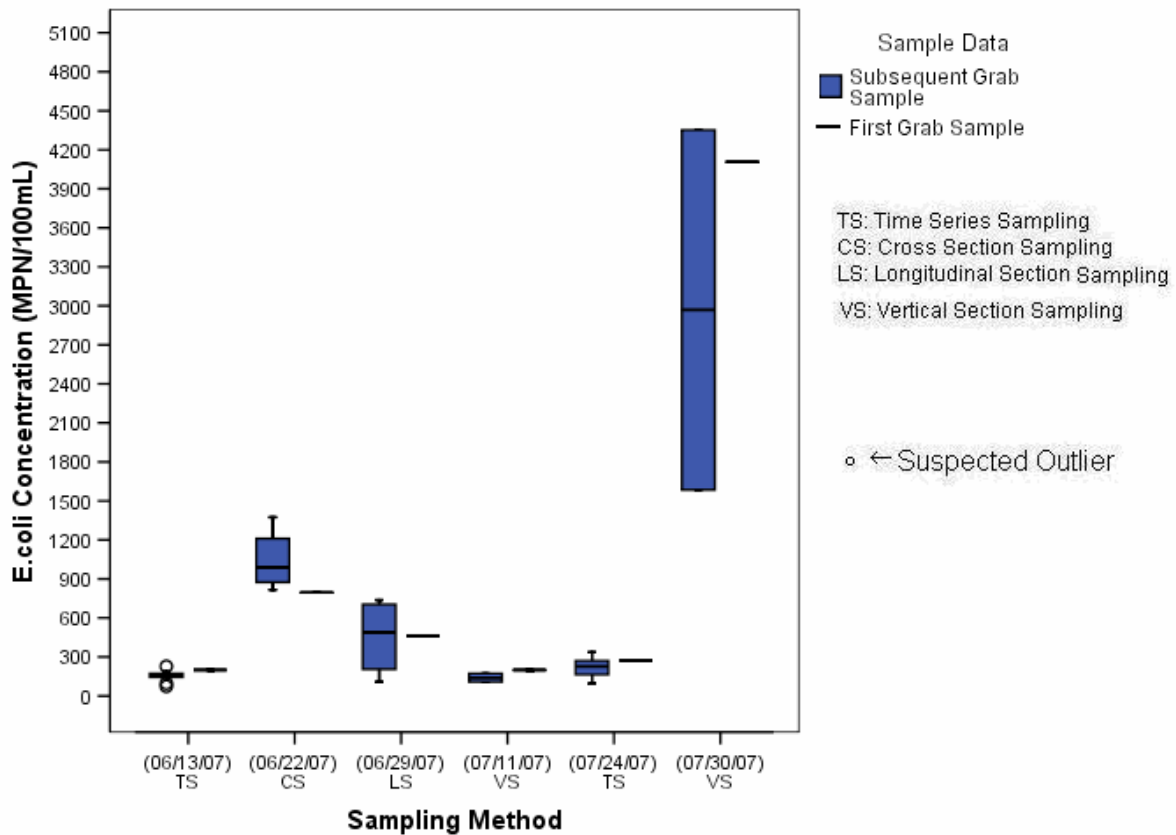
Figure 4-6
Boxplots Comparing the First Grab Sample vs. Entire Sample Set
for *E. coli* Concentration Collected from Six Sampling Events
at Site UAA-4 (East Fork) During June and July 2007

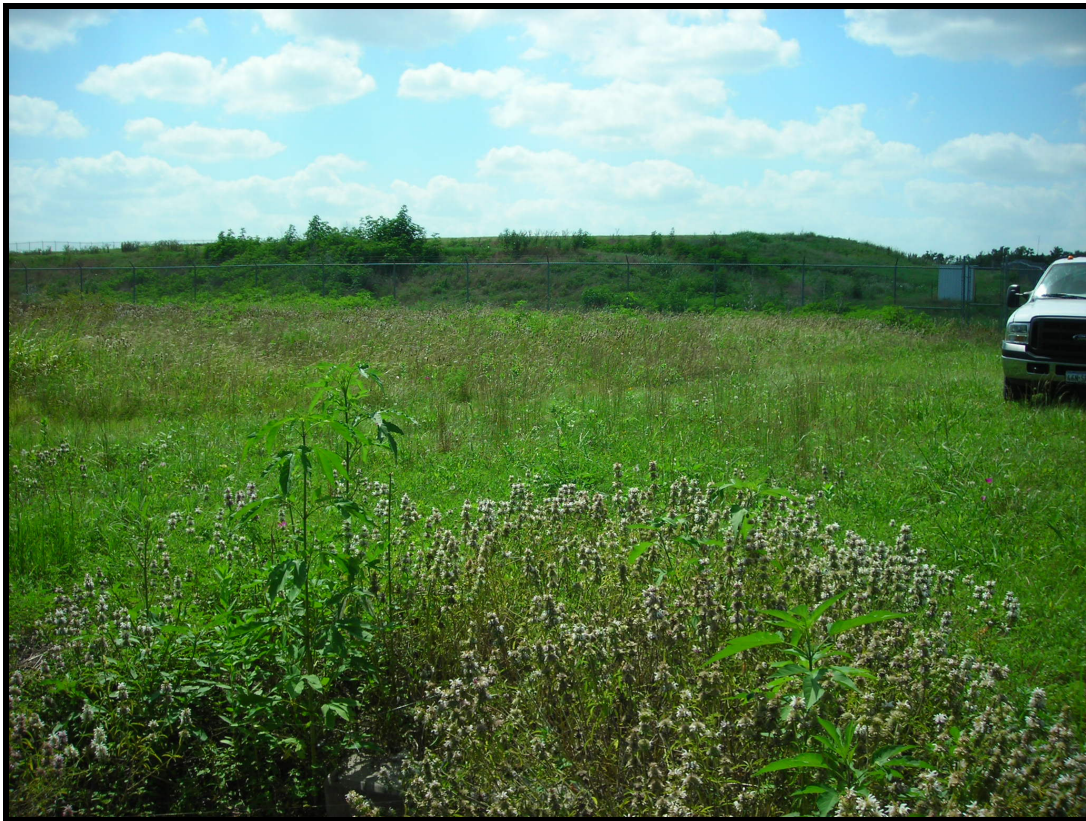
Source of waste water discharge: Town of Industry waste water treatment plant.

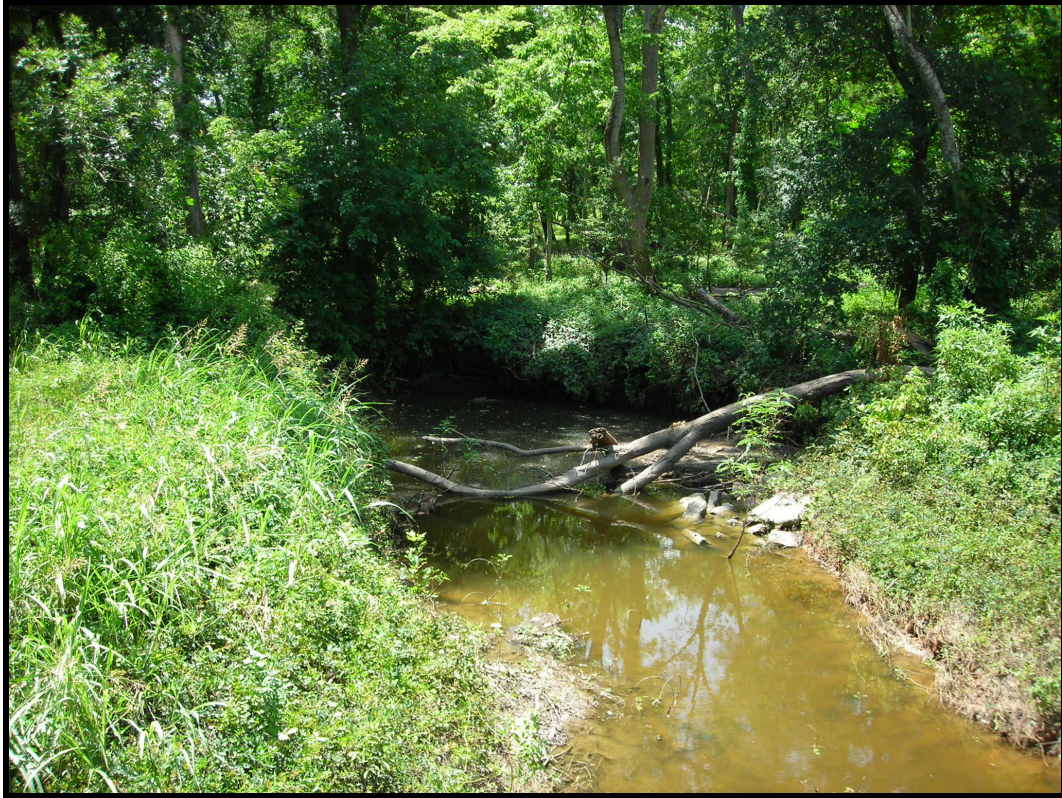
Dry weather conditions: West Fork of Mill Creek, upstream of the bridge on Industry Road at Blue Hole Road.

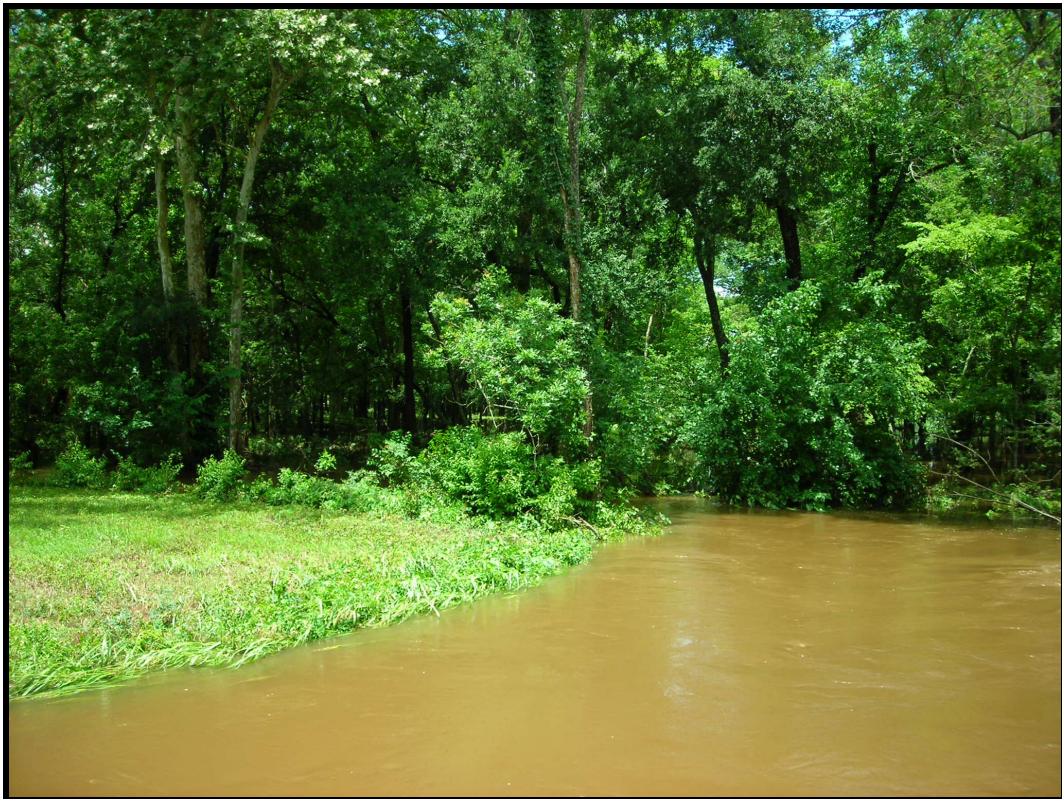
Wet weather conditions: Same site as above.

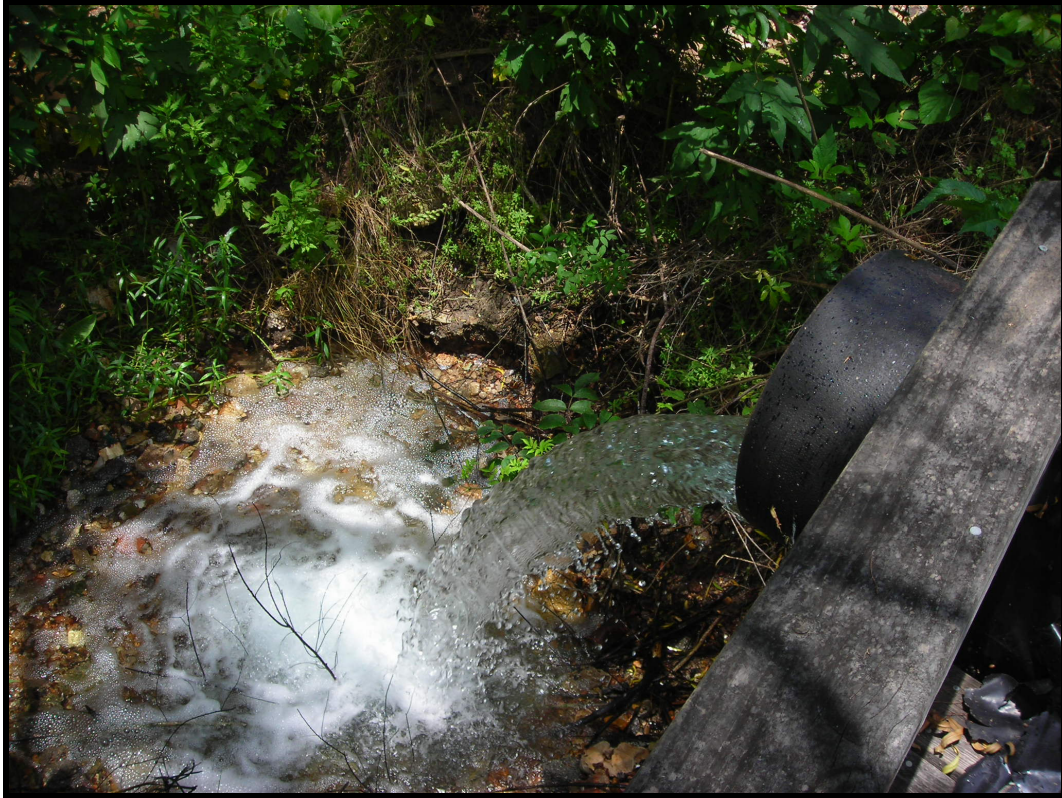
Possible source of bacteria: Outfall structure for the City of Bellville; located on Boggy Creek, a tributary to Mill Creek.

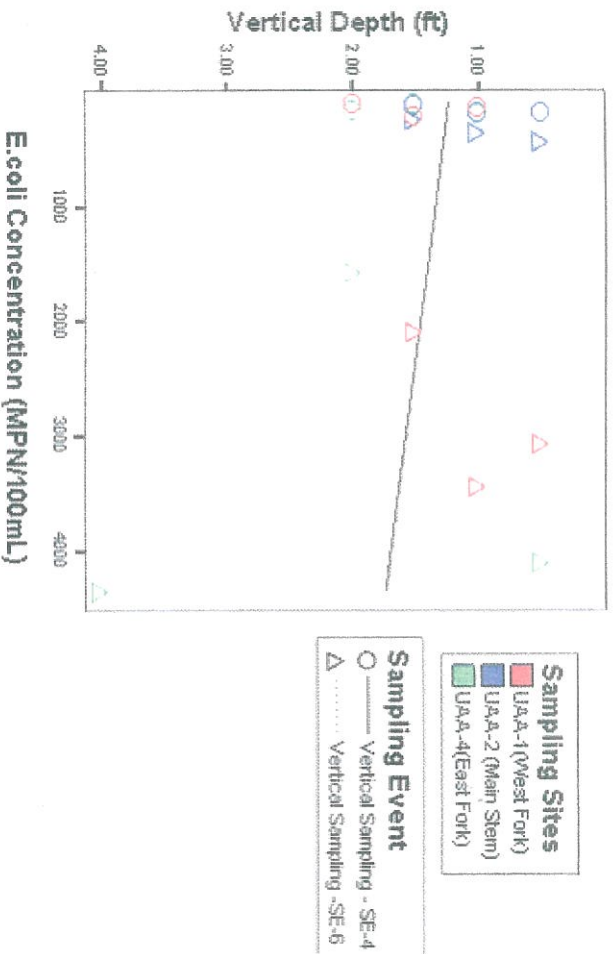
Figure J-12
EC Concentrations Obtained from Vertical Section
Sampling vs. Vertical Depth from Sampling Events
Conducted on July 11 and July 30, 2007
