# Texas Southern University Automated Vehicle

## Final Report

July 2020

Center for Transportation Training and Research

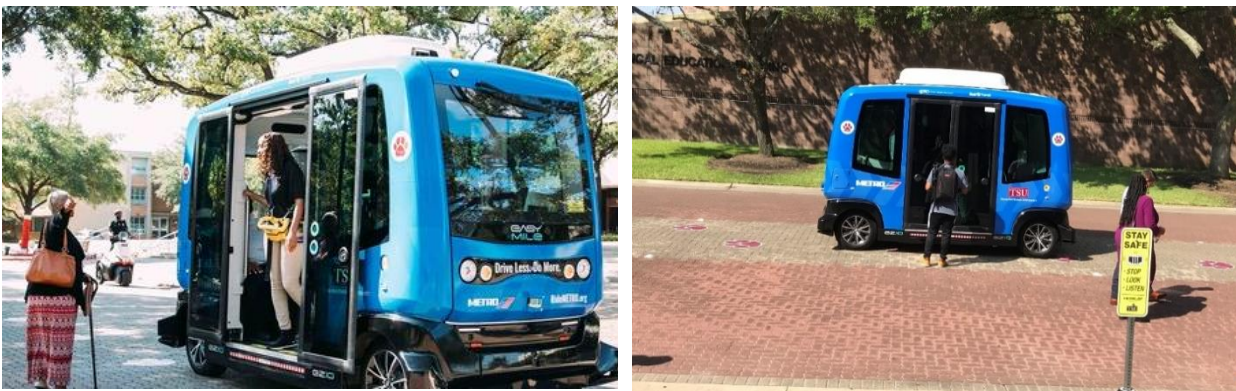
Figure 17. *Station Stopping at the Center Lane of the Tiger Walk Elevator Configuration*

The decision was made to implement the second option, the *Center Lane Boarding Elevator Configuration* at the beginning of the fall semester. This option provided a potential improvement to the station boarding process and provided a better location for wheelchair ramp deployment (i.e., mitigating the risks with ramp deployment into the active pedestrian lane). An ancillary benefit of this option was an up to 3-minute reduction in end-to-end running time, depending on the dwell time at stops along the path. Figure 17 provides an image of Center Lane operation and boarding along the Tiger Walk.

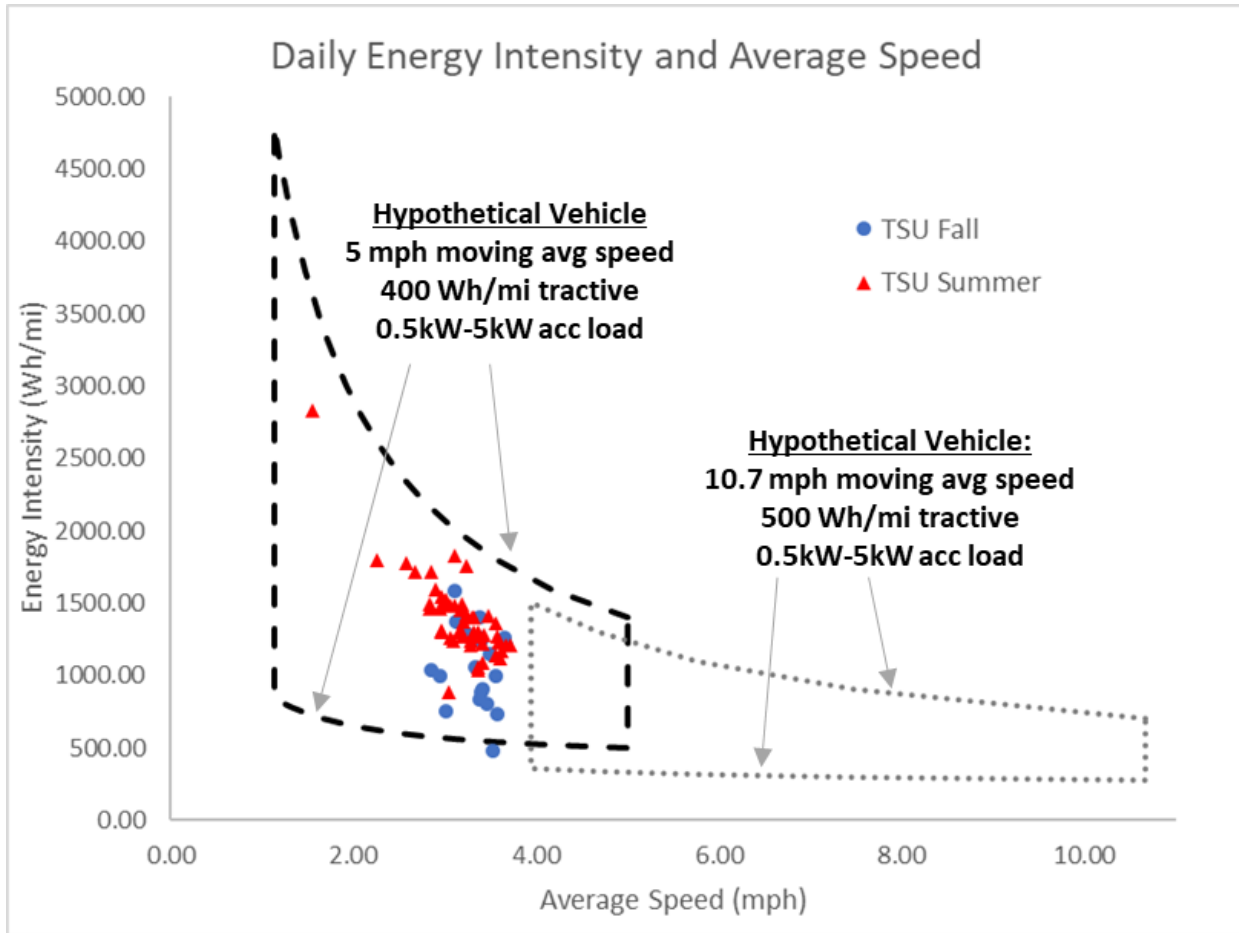
Figure 21. Energy Consumption Data as a Function of Average Speed and Seasonal Climate Impacts  
 Source: Matt Shirk, Idaho National Laboratory

In addition, INL investigated the ambient temperature for each day that records were available in order to assess what impacts on energy consumption could be attributed to onboard air conditioning and/heating equipment used for the passenger compartment temperature control. These recordings resulted in a rich database of power consumption as a function of vehicle-miles travelled and ambient climatological conditions while the vehicle was in service between June 10<sup>th</sup> and November 20<sup>th</sup>, 2019. The complete set of data and associated operational information was a joint effort of INL researchers with

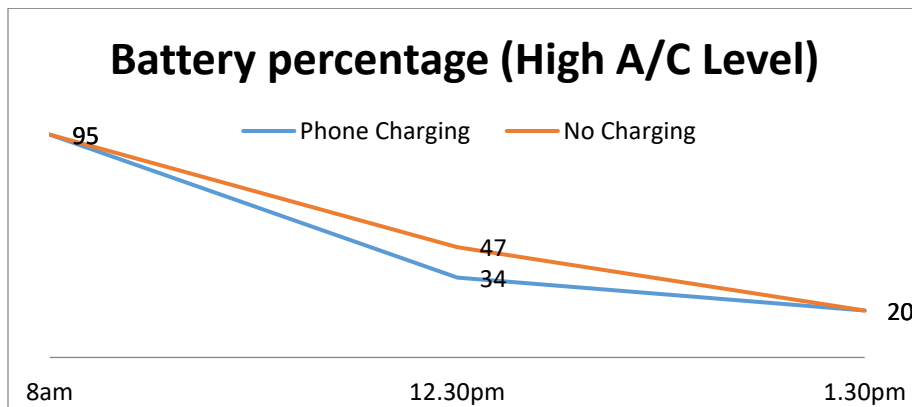
Figure 23. Scenario High Air Conditioning

As observed in Figure 23, the rate of depletion of the battery at a high A/C level was higher with phone charging than without phone charging. On both Monday and Tuesday of that week, the vehicle was withdrawn at 1:30 p.m. - an hour before its scheduled end of operation - to recharge so it could resume operation at 5 p.m. as scheduled. So, it is worthwhile to note that when the A/C level was high, the vehicle was unable to complete the scheduled hours of operation on a single charge due to high rate of battery depletion, especially with phone charging.

Although many elements may contribute to the vehicle’s battery depletion, it is worthwhile to note, based on these results, that A/C level and phone charging have a significant effect on the depletion rate of the battery.

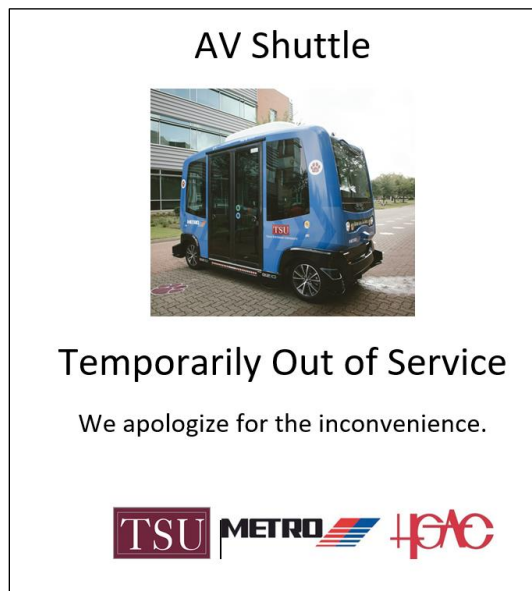
Figure 25. Manually-Displayed Sign

**IMPROVING PASSENGER INFORMATION:** METRO operates a systemwide GPS tracking system to inform riders of arrival times of their buses and trains. However, integrating the AV into METRO’s notification system did not occur because it would have required installing additional equipment, and EasyMile did not allow any modifications to the vehicle. Throughout the AV demonstration, service interruptions occurred due to weather, major campus events, or vehicle maintenance. During these times, the project team was unable to broadcast messages about service limits or cessation via TSU announcements or METRO’s system. Instead, the project team placed “Out of Service” placards at each shuttle stop (Figure 25). Phase II of the AV demonstration will involve up to three vehicles and will operate an extensive route. As Phase II begins, an automated notification system must be employed to provide predictability of service for riders at TSU and the University of Houston (UH).
