San Jacinto River Waste Pits Superfund Site

Community Awareness Committee Meeting
4/4/2012

Post TCRA Quarterly Inspection (January 2012)

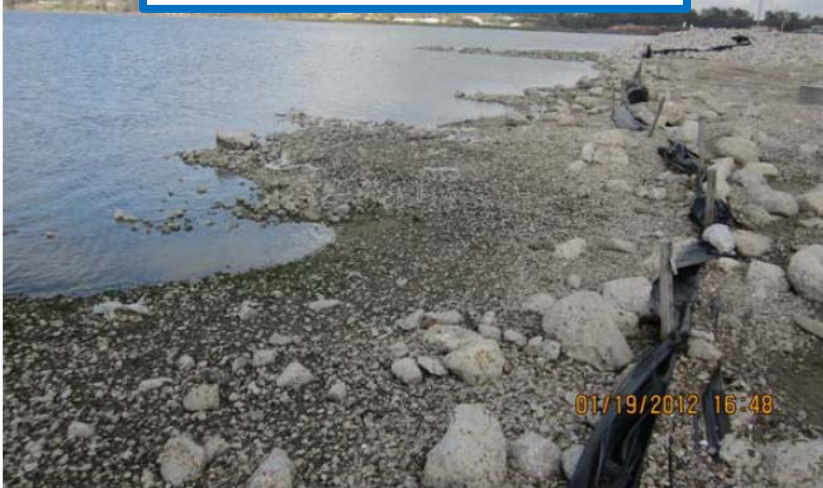
Western Cell - January 2012
Inspection

Photo: 48 Silt fencing along the northern shoreline of the Western Cell (view northeast)

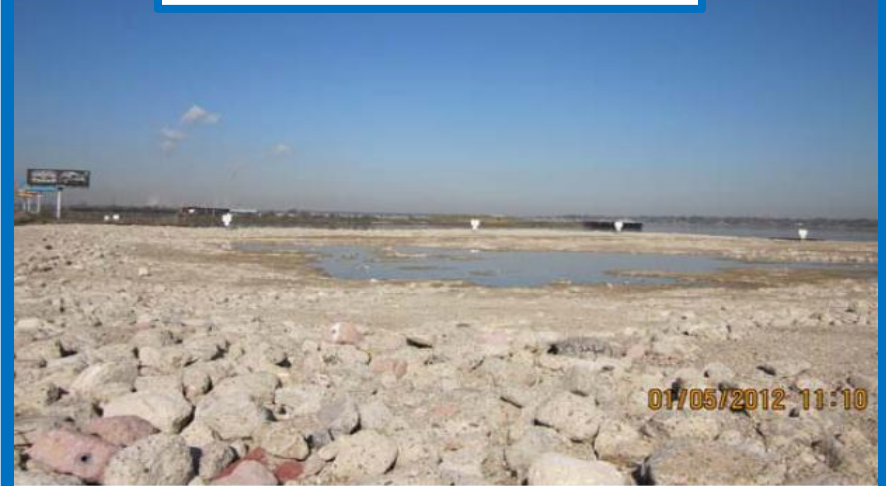
Western Cell - January 2012
Inspection

Photo: 02 View of Western Cell from the Central Berm (view northwest)

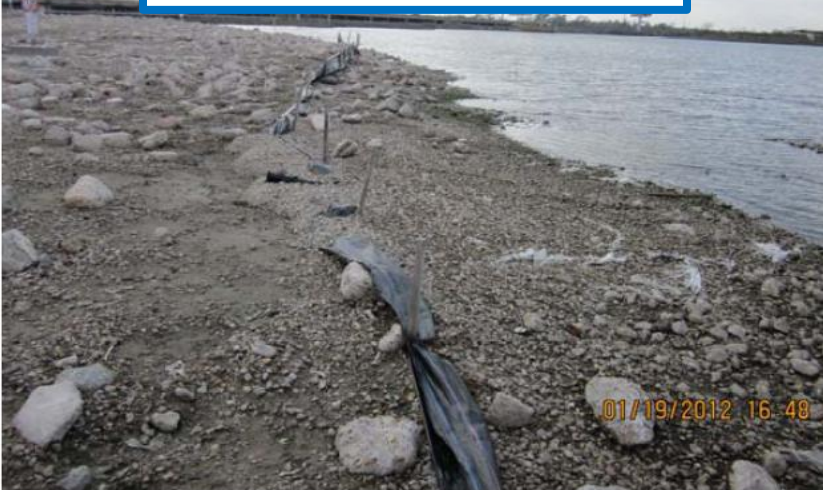
Western Cell - January 2012
Inspection

Photo: 49 Silt fencing along the northern shoreline of the Western Cell (view west)

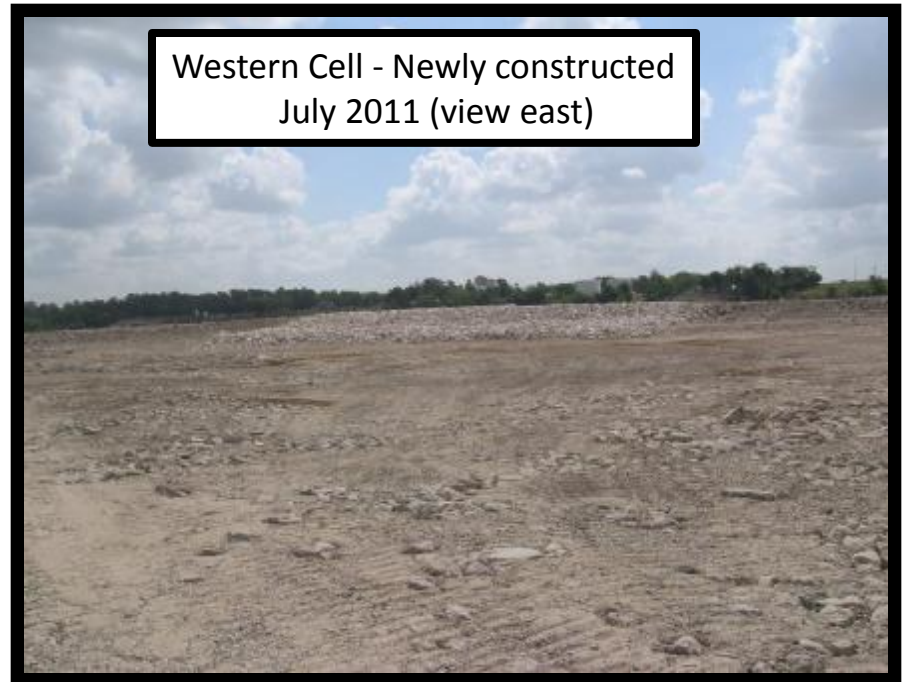
Western Cell - Newly constructed
July 2011 (view east)

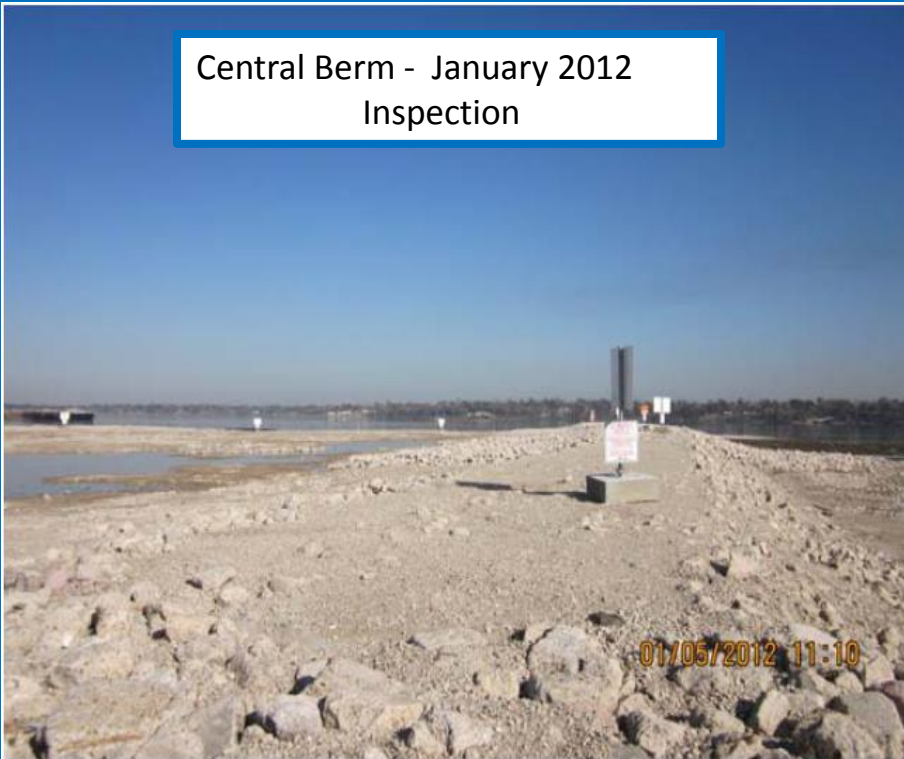
Central Berm - January 2012
Inspection

Photo: 03 View of Western Cell and Central Berm from the Central Berm (view north)

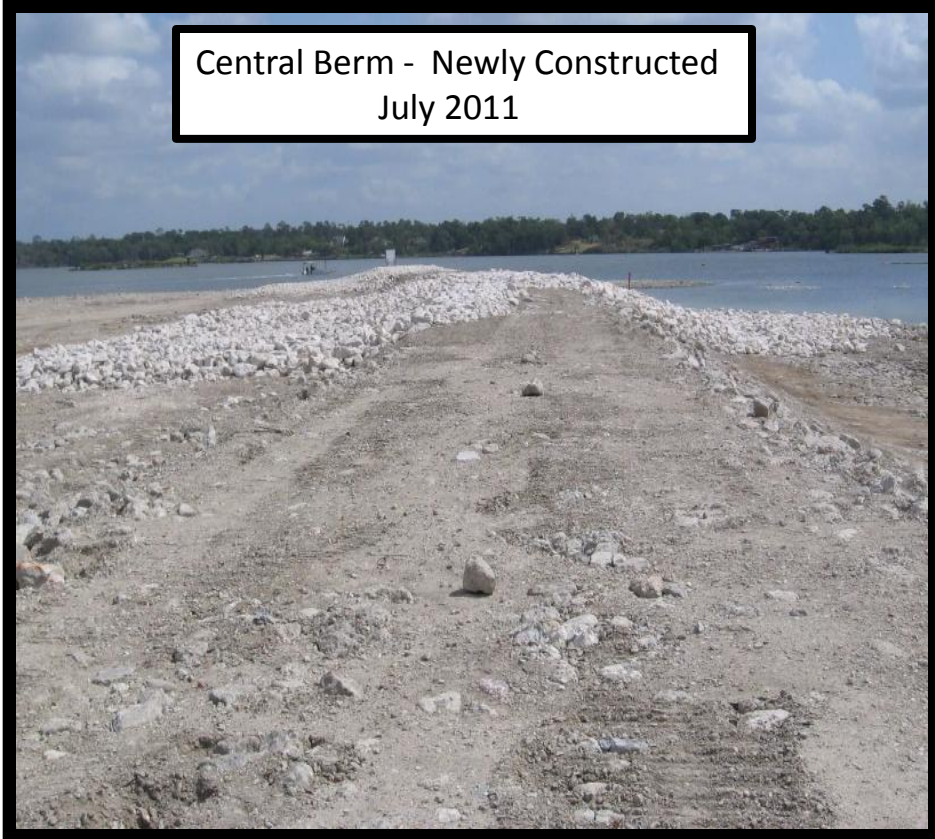
Central Berm - Newly Constructed
July 2011

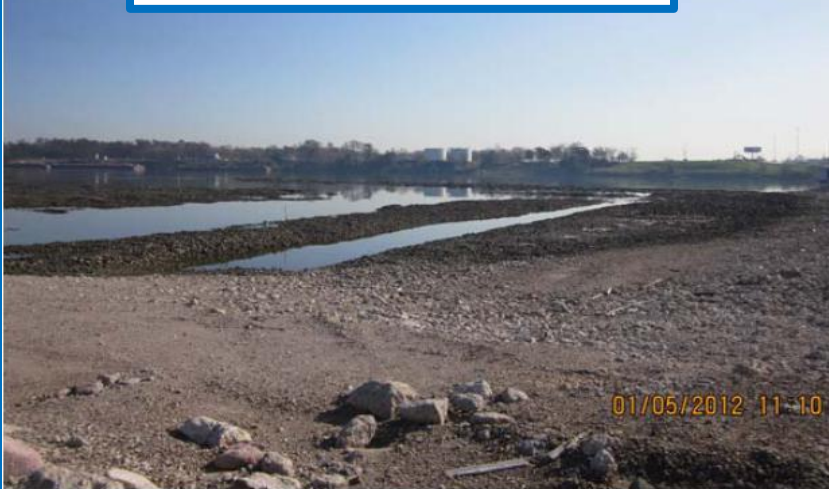
Eastern Cell - January 2012
Inspection

Photo: 01 View of Eastern Cell from the Central Berm (view east)

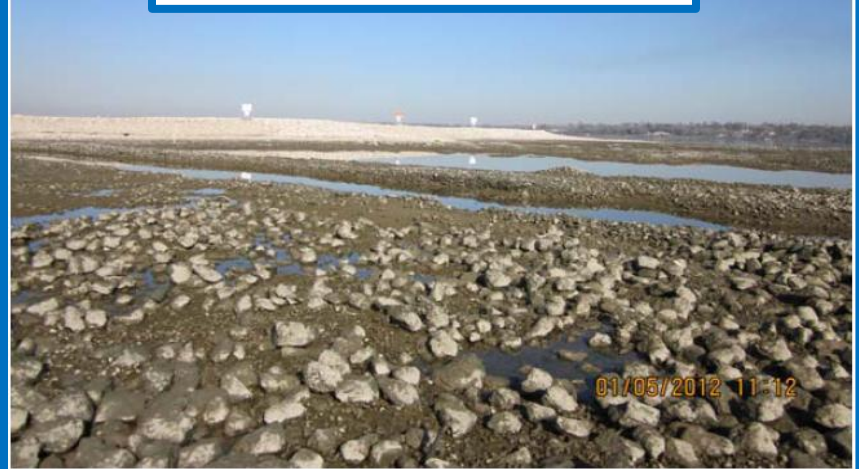
Eastern Cell - January 2012
Inspection

Photo: 07 View of Eastern Cell and Central Berm from the Eastern Cell (view northwest)

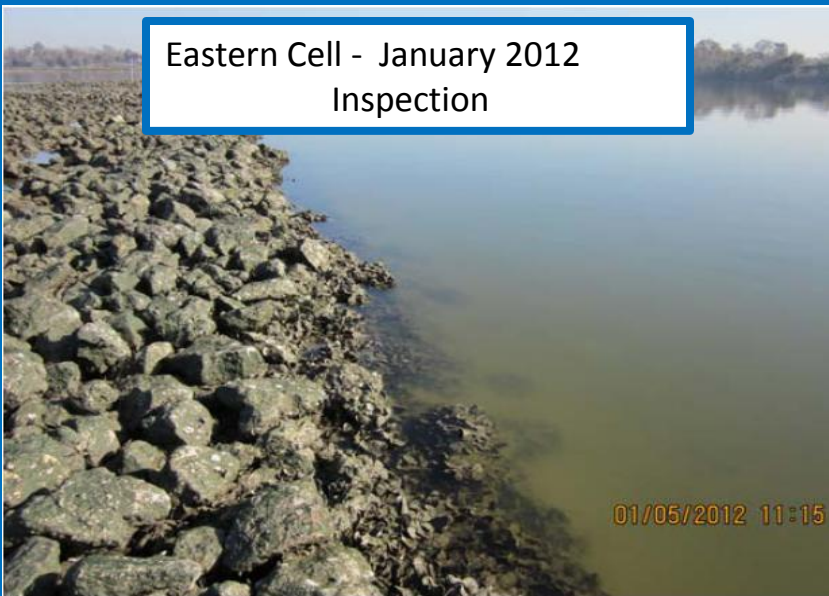
Eastern Cell - January 2012
Inspection

Photo: 12 View of thickened edge Eastern Cell adjacent to the San Jacinto River; photo shows intact armored cap for areas unable to be surveyed (view north)

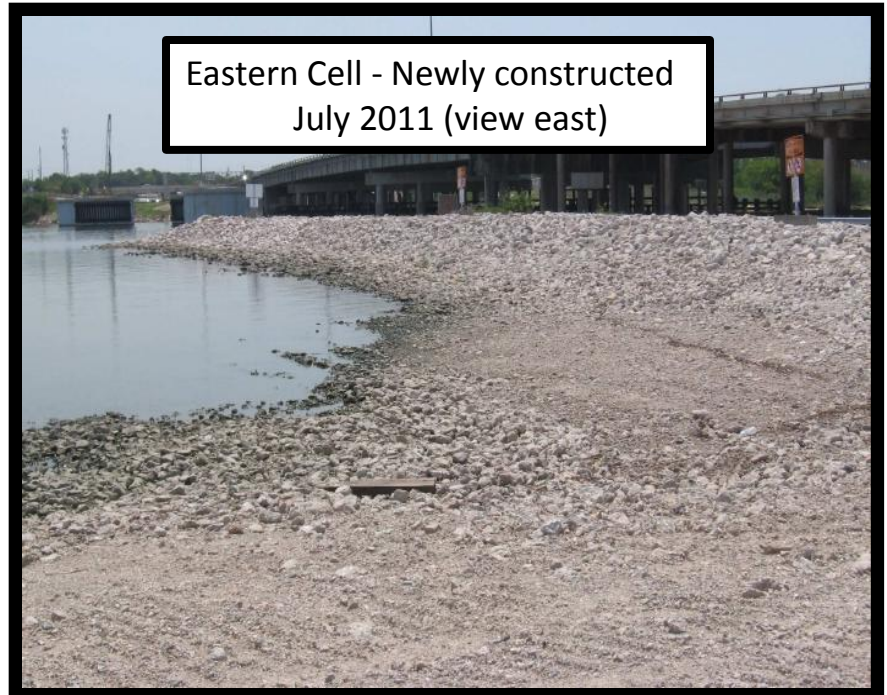
Eastern Cell - Newly constructed
July 2011 (view east)
