San Jacinto River Waste Pits Superfund Site

November 15, 2012

August 2011 Residential Soil
Samples for Dioxin
and Furan Analysis

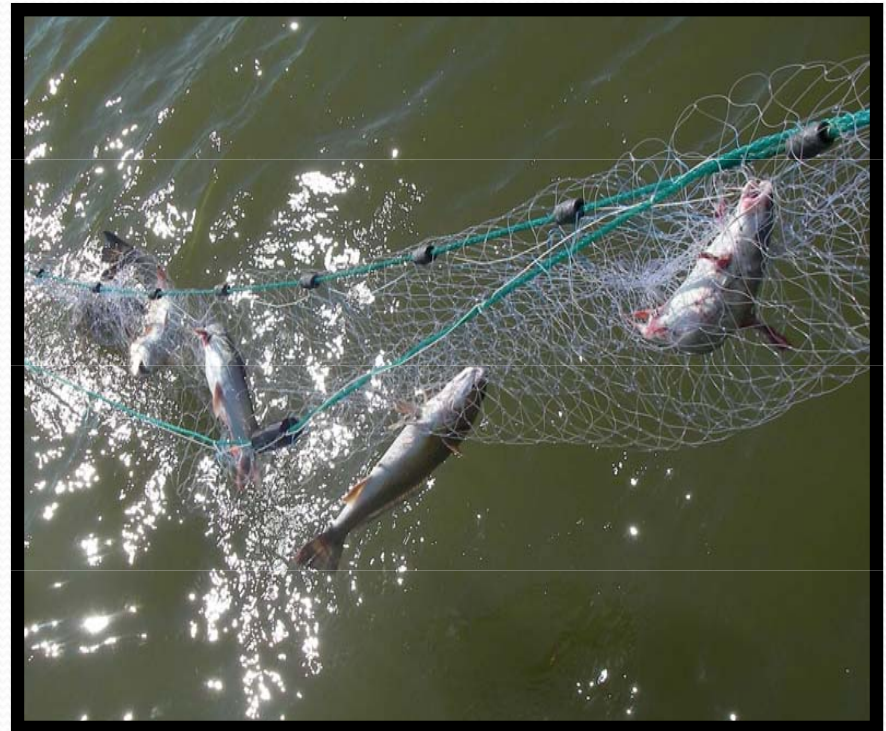
30 Hardhead catfish samples in site boundary.

● Fillet samples – ng/kg TEQ_{DF} Dioxin

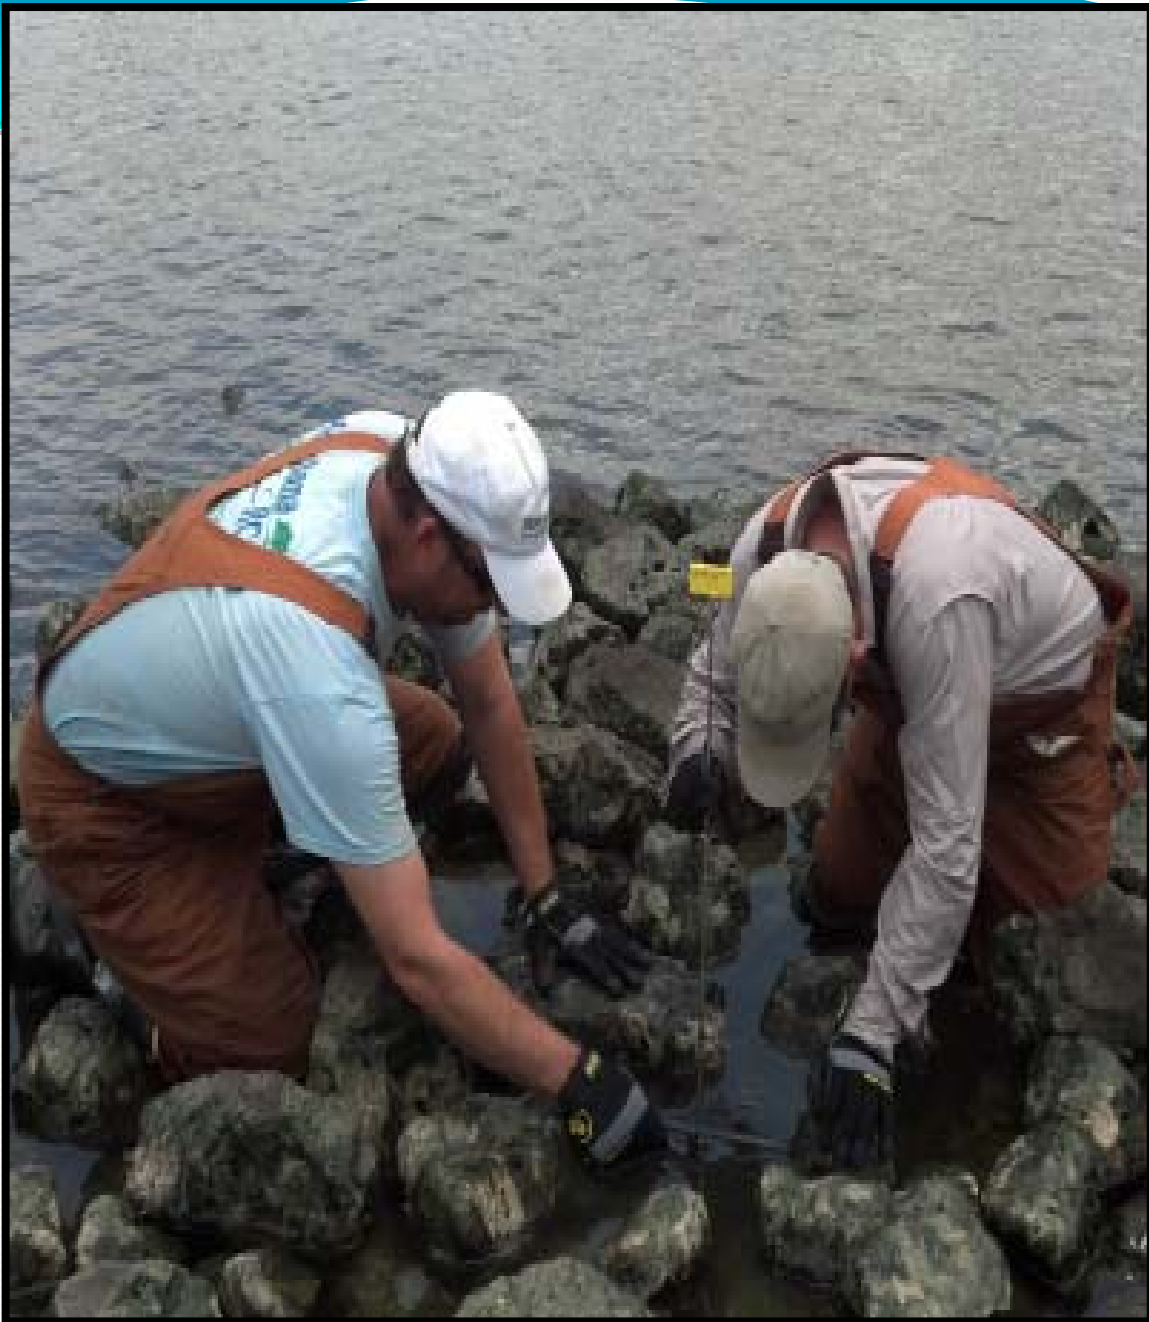
Waste Pits Cap Porewater Sampling Locations

What is “Porewater”?

- Water in the space between the rock and soil particles of the cap;
- Samplers inserted into the cap to measure dioxin and furan in the pore water.

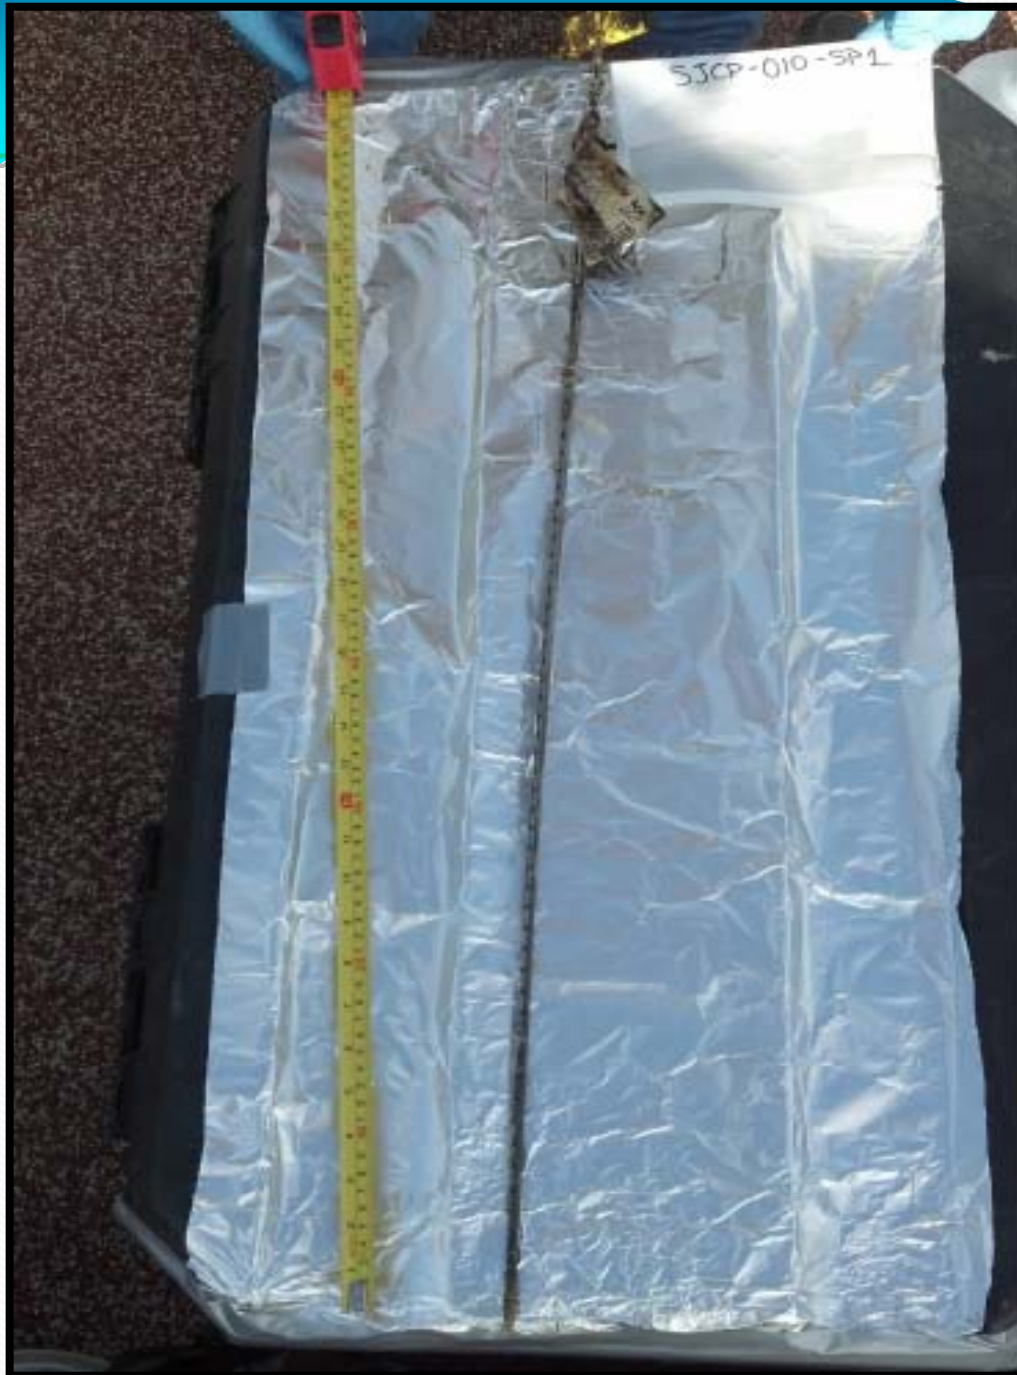
Cap Porewater Assessment Results

- Dioxin not detected in any samples;
- Furan at very low levels in three out of 48 samples and not detected in the other 45 samples;
- Neither dioxin or furan were detected in the overlying surface water.

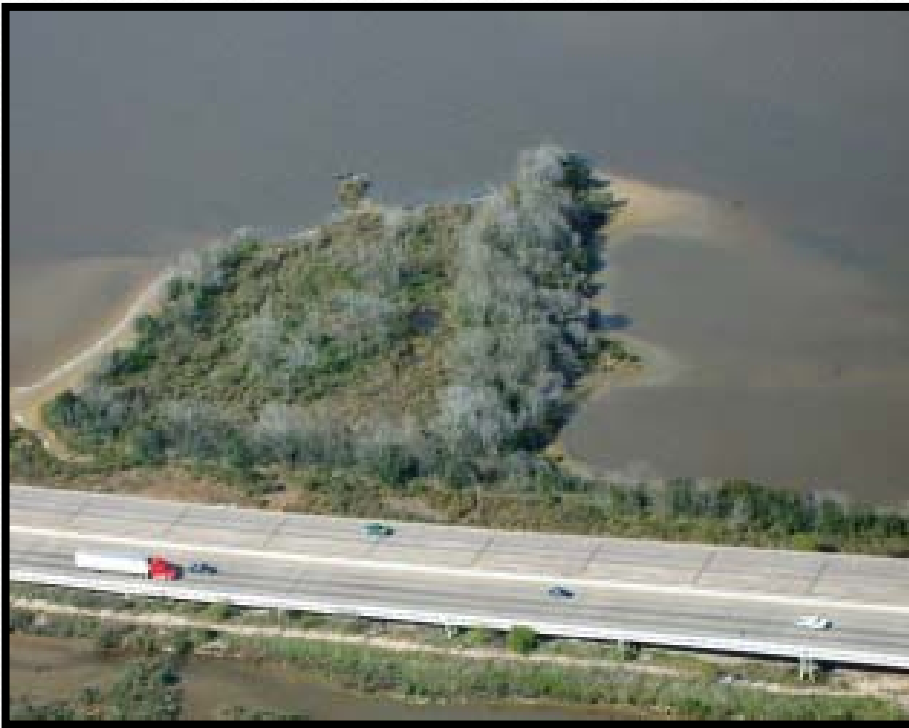
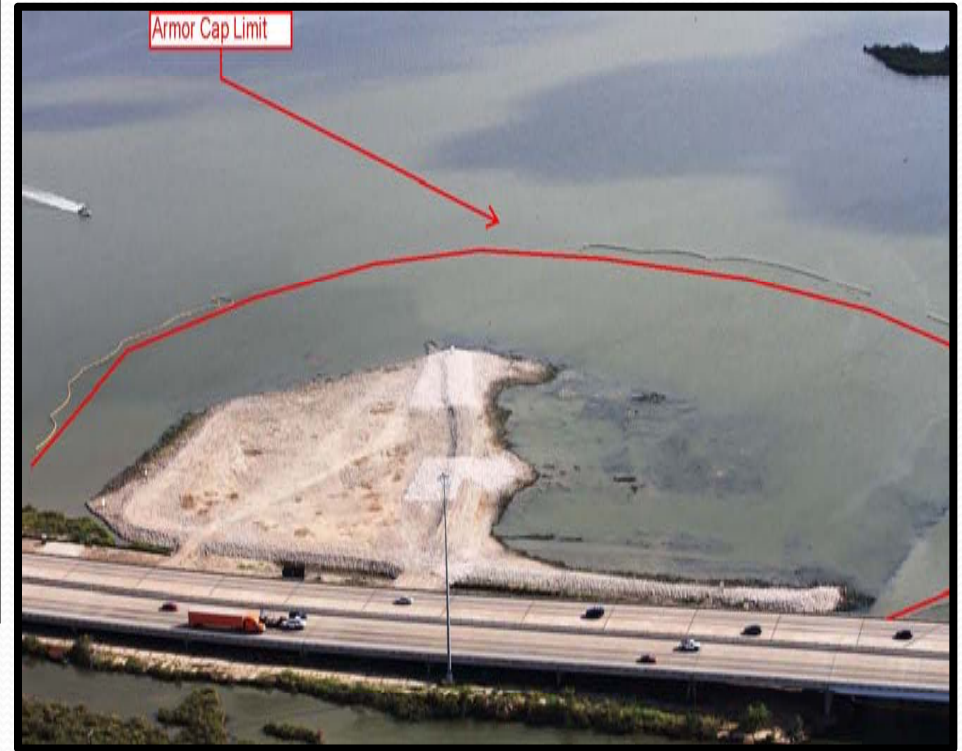
TCRA Update – Western Berm Erosion

- RP notification of berm erosion July 23, 2012;
- EPA inspection of cap July 24, 2012;
- Completion of repairs of western berm August 6, 2012;
- EPA, USACE, and RP assessment of cap design/construction.

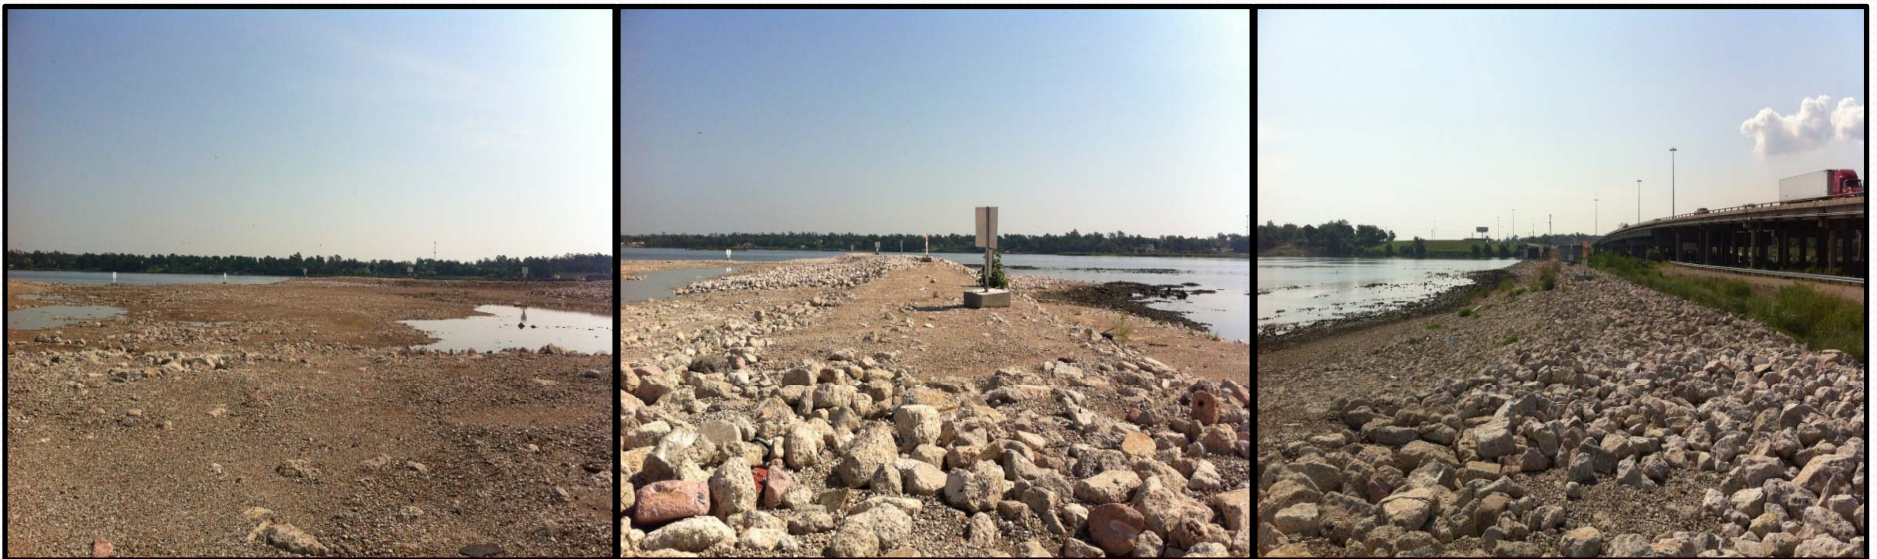
TCRA Update – Armor Cap Inspections

Results of Cap Inspections – February / May / October 2012:

- Cap observed to be in visually intact;
- Site security fencing and signage intact;
- No evidence of trespassers or fishing around waste pits;
- 1st and 2nd quarterly topographic surveys - no cap repair needed.
