THE SECRETARY
OF THE INTERIOR'S
**STANDARDS FOR
THE TREATMENT
OF HISTORIC
PROPERTIES**

WITH
**GUIDELINES FOR
PRESERVING,
REHABILITATING,
RESTORING &
RECONSTRUCTING
HISTORIC
BUILDINGS**

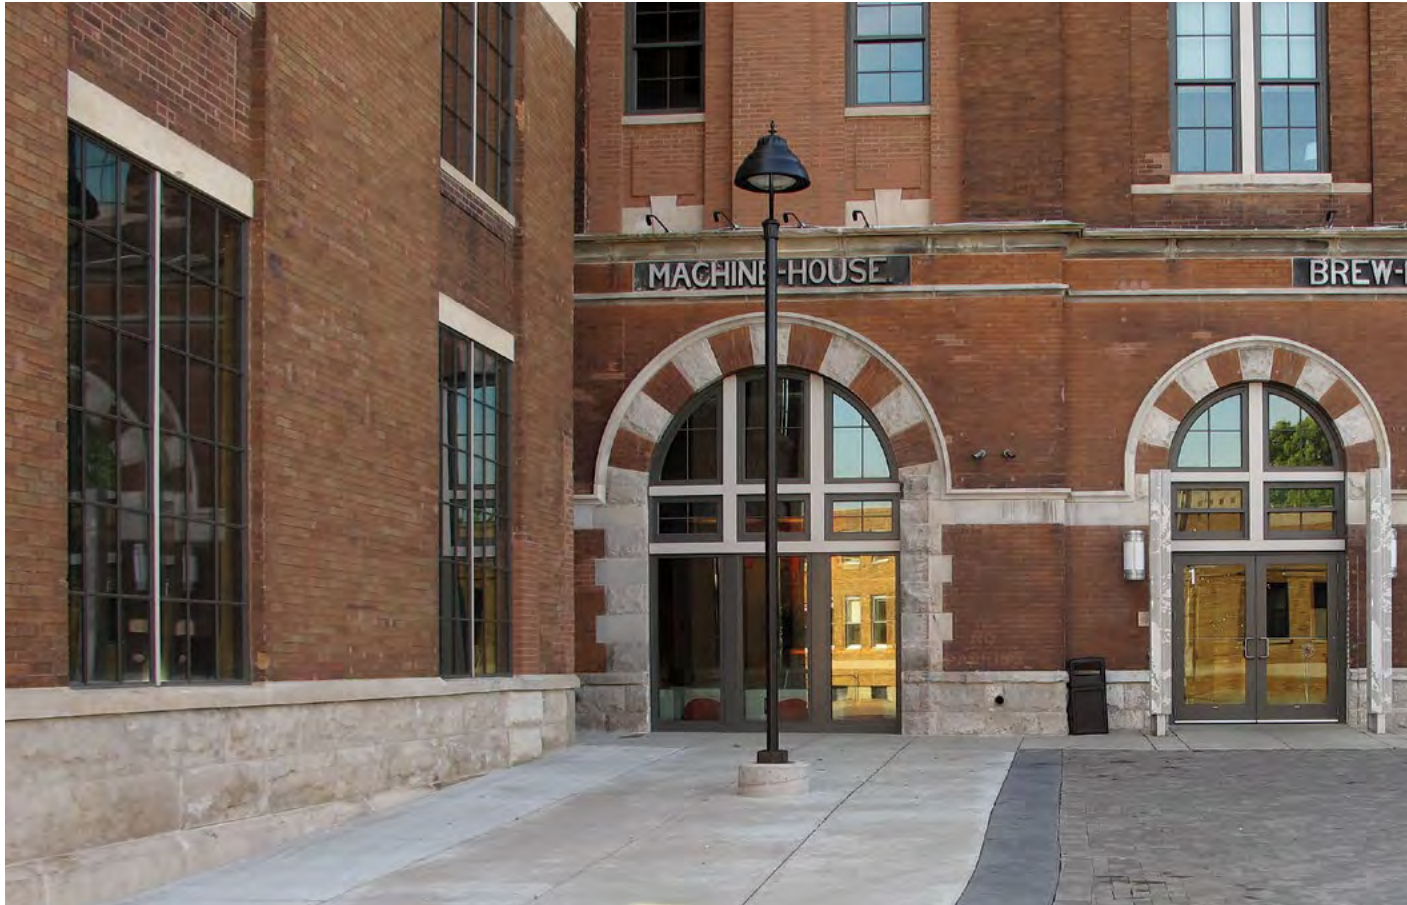
It is often necessary to make modifications to a historic building to make it compliant with accessibility code requirements. Federal rules, regulations, and standards provide guidance on how to make historic buildings accessible. Work must be carefully planned and undertaken in a manner that results in minimal or no loss of historic exterior and interior character-defining spaces, features, or finishes. The goal should be to provide the highest level of access with the least impact to the historic building.

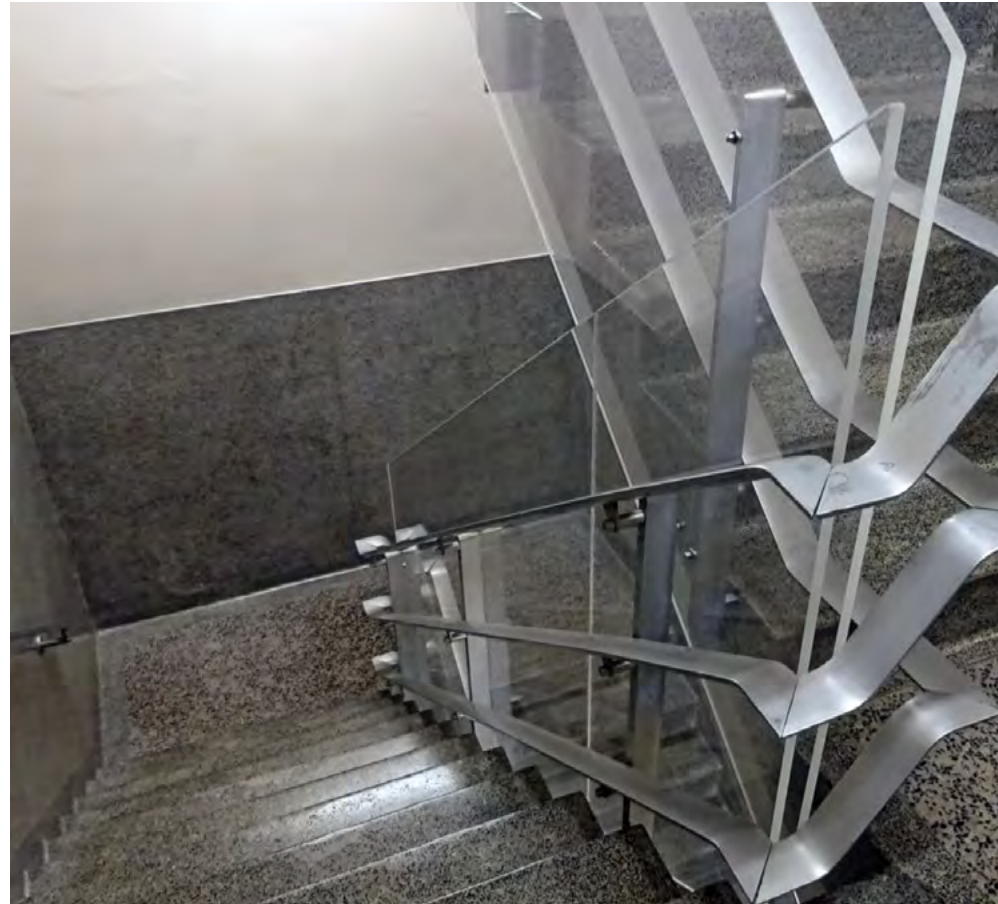
Resilience to Natural Hazards

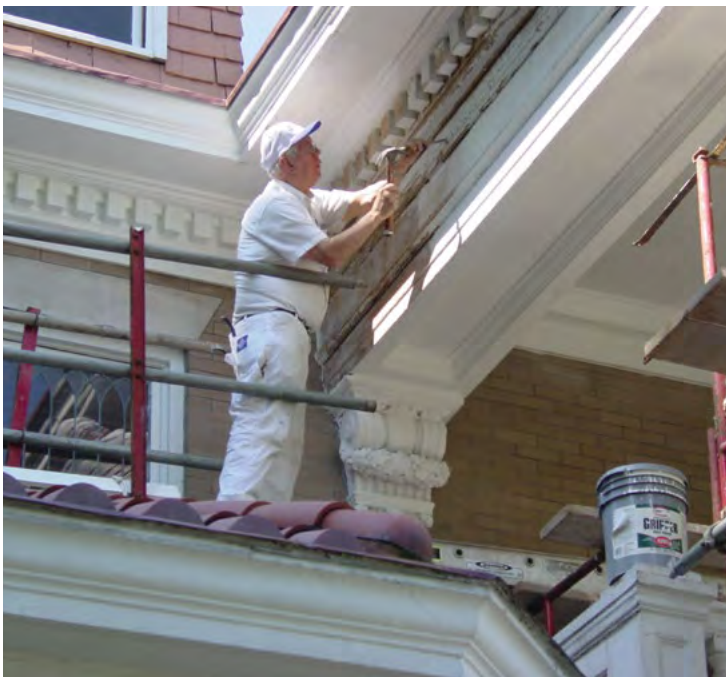
[12] Repair and limited replacement in kind to match deteriorated wood porch features is always a recommended preservation treatment.

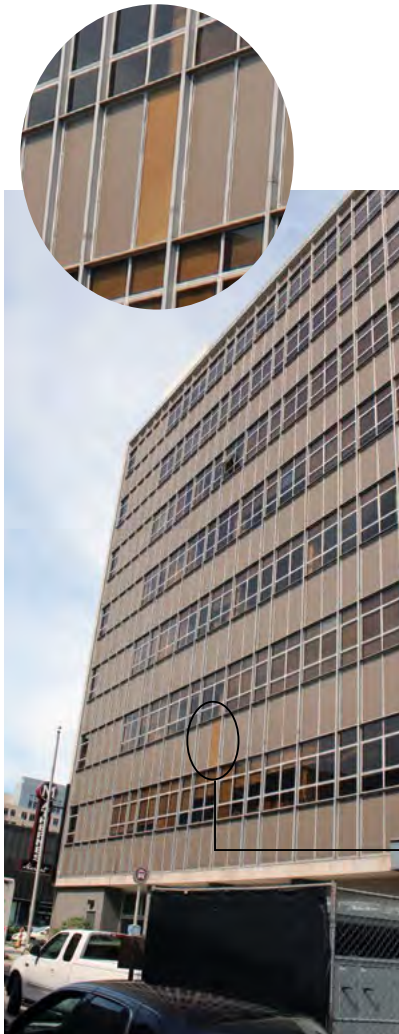
[16] Plywood provides temporary protection for an opening where a damaged spandrel panel was removed until a matching replacement panel can be installed.

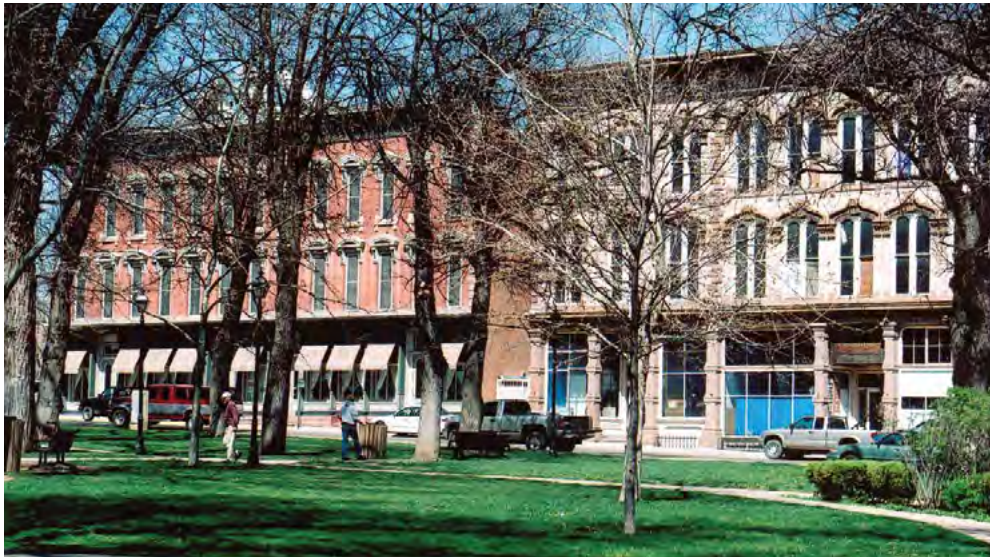
[23] The city square is important in defining the character of the historic setting in this small town.

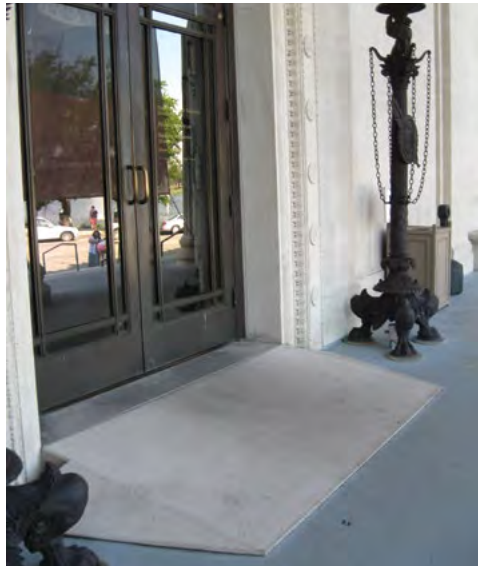
[27] The access ramp at the left of the entrance is concealed by a hedge which minimizes its visibility and impact on the character of the historic apartment building.

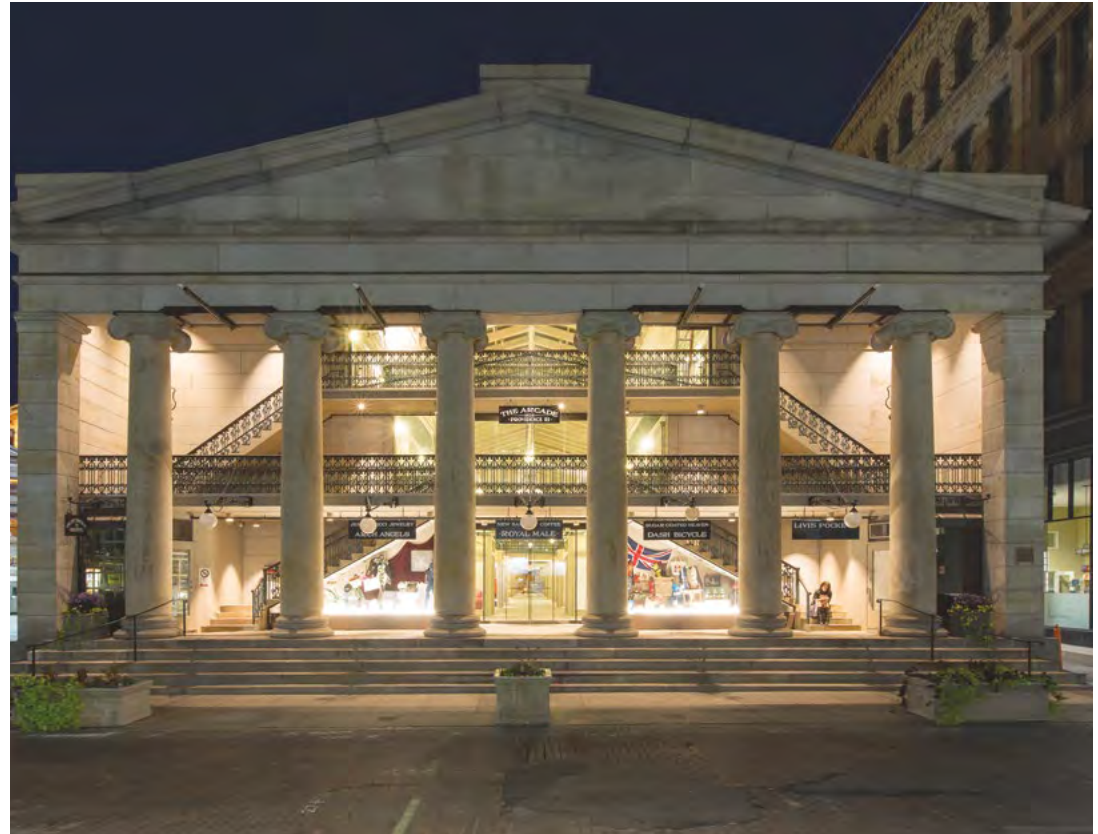
Standards for Rehabilitation

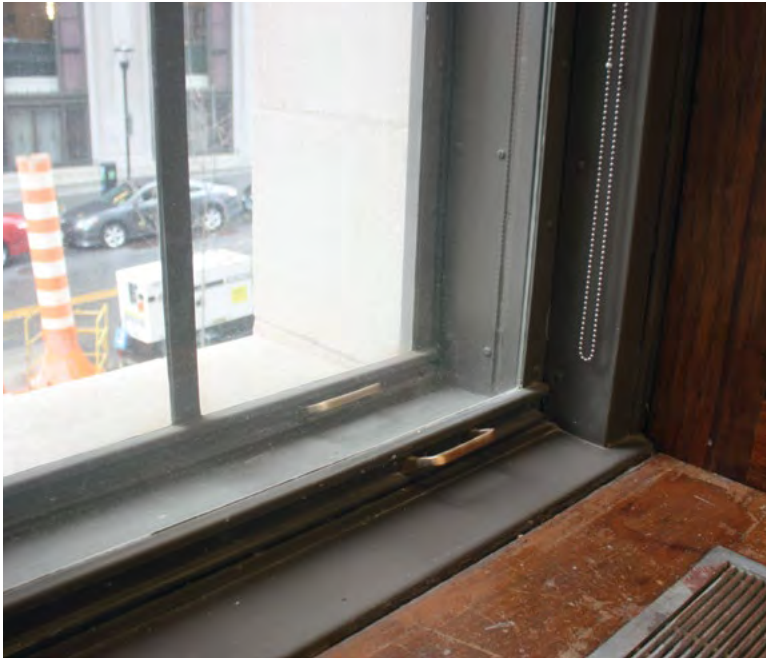
[18] The historic metal storm windows in this 1920s office building were retained and repaired during the rehabilitation project.

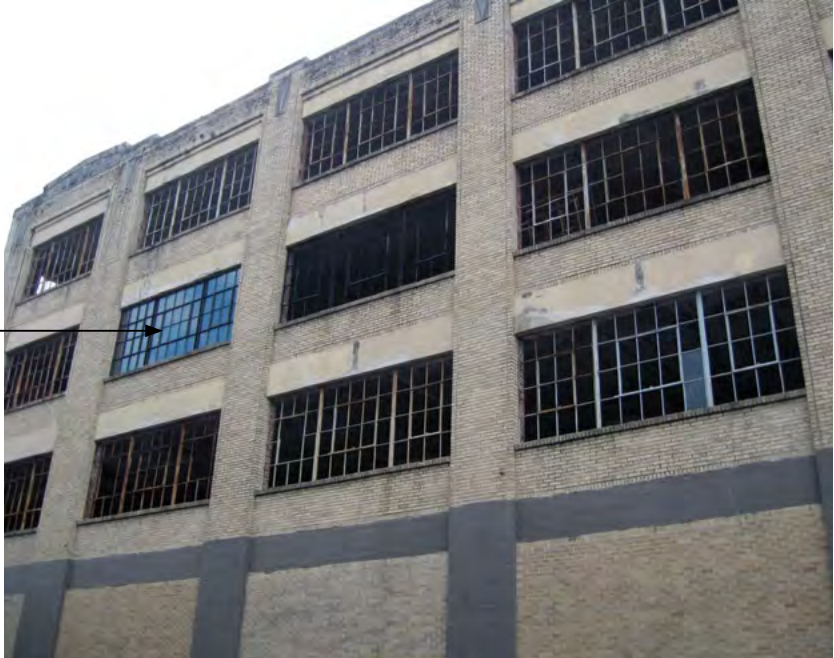
[19] Installing a mockup of a proposed replacement window can be helpful to evaluate how well the new windows will match the historic windows that are missing or too deteriorated to repair.

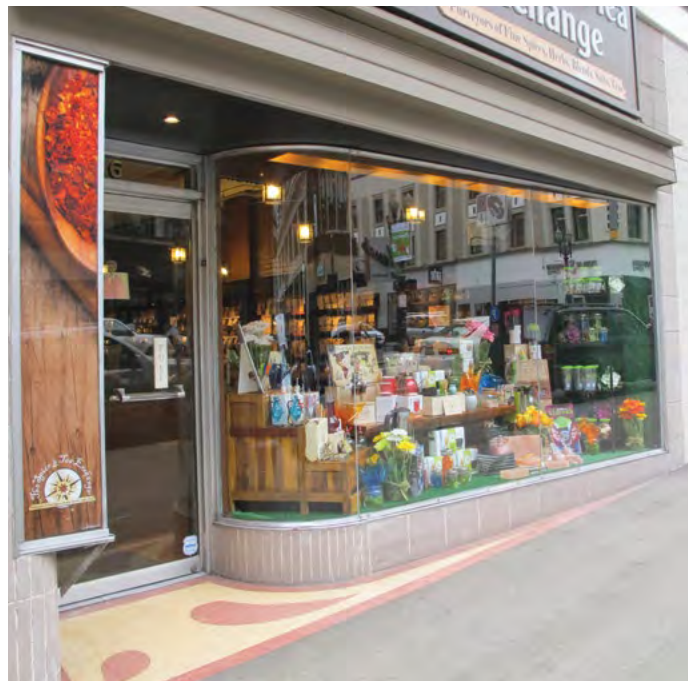
[27] This original c. 1940s storefront, with its character-defining angled and curved glass display window and recessed entrance with a decorative terrazzo paving, is in good condition and should be retained in a rehabilitation project.

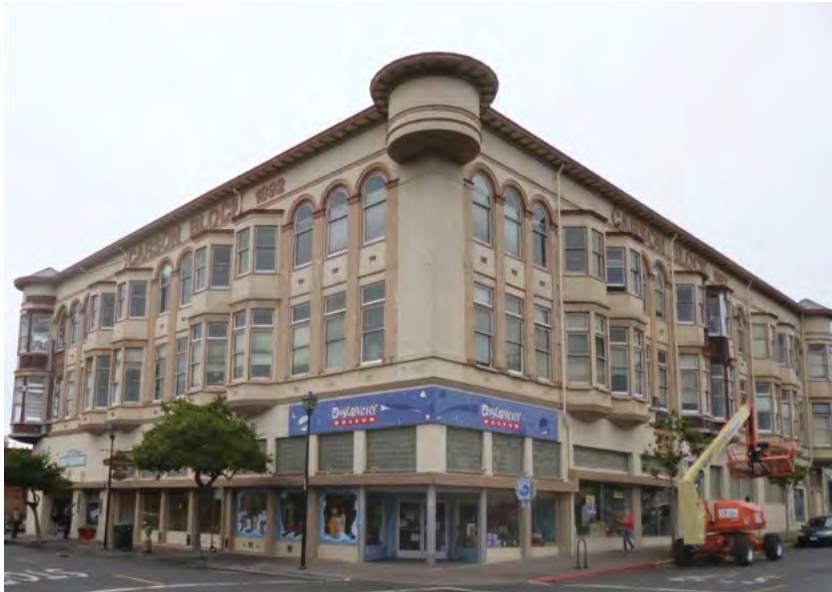
[32] (a-b) The rehabilitation of the 1892 Carson Block Building in Eureka, CA, for its owner, the Northern California Indian Development Council, included recreating the missing corner turret and sensitively introducing seismic reinforcement (c) shown here (opposite page) in a secondary upper floor office space. Photos: Page & Turnbull.

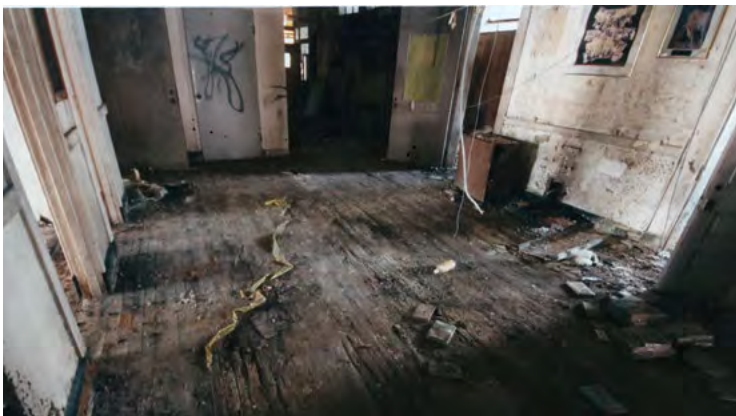
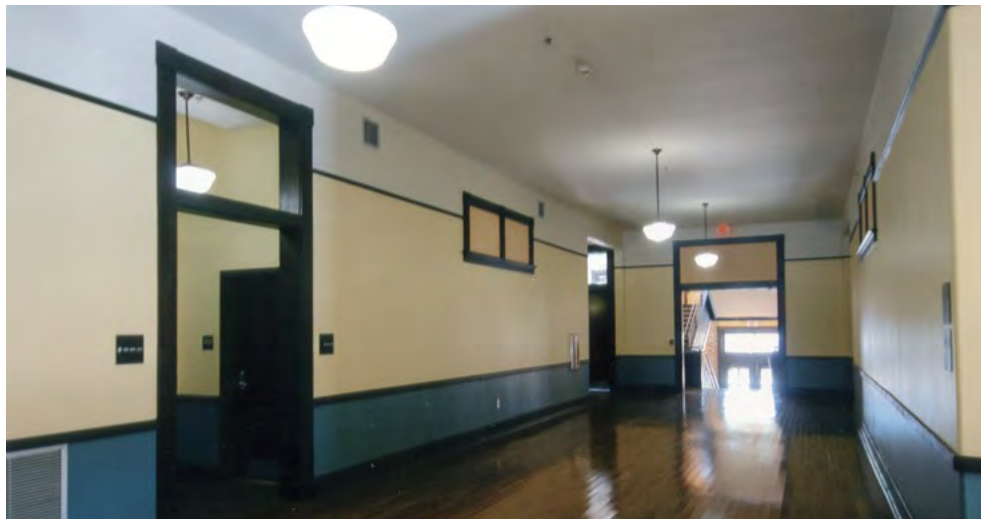
[35] (a) Although deteriorated, the historic school corridor, shown on the left, with its character-defining features, including doors and transoms, was retained and repaired as part of the rehabilitation project (b).

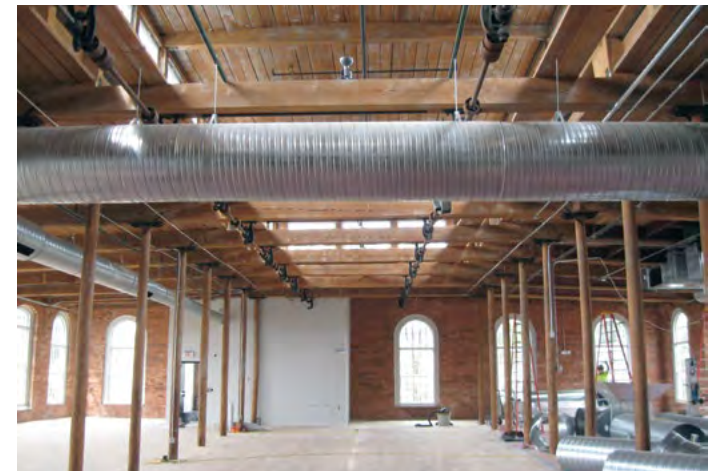
INTERIOR SPACES, FEATURES, AND FINISHES

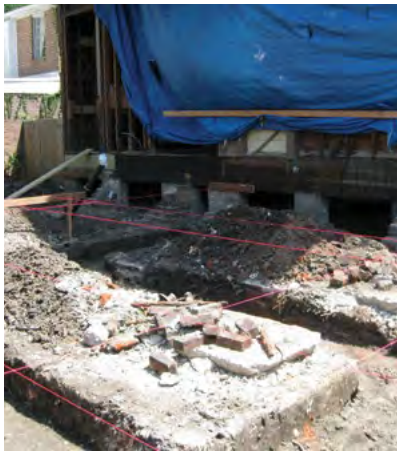
[45] Undertaking a survey to document archeological resources may be considered in some rehabilitation projects when a new exterior addition is planned.

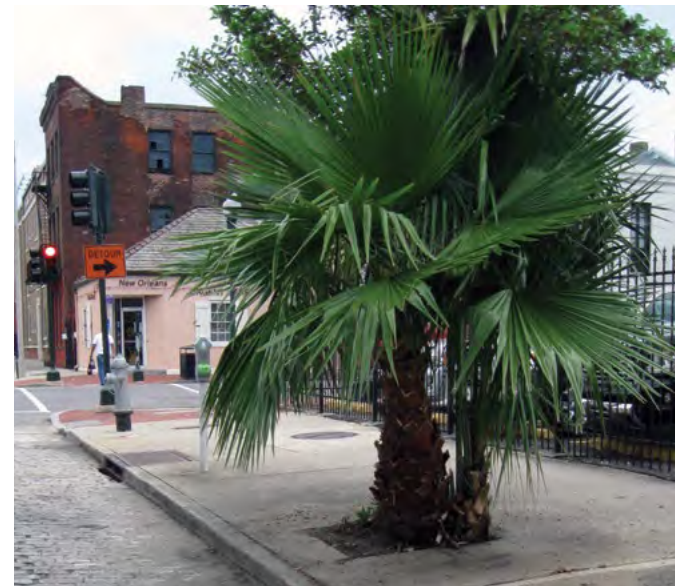
SETTING (DISTRICT / NEIGHBORHOOD)

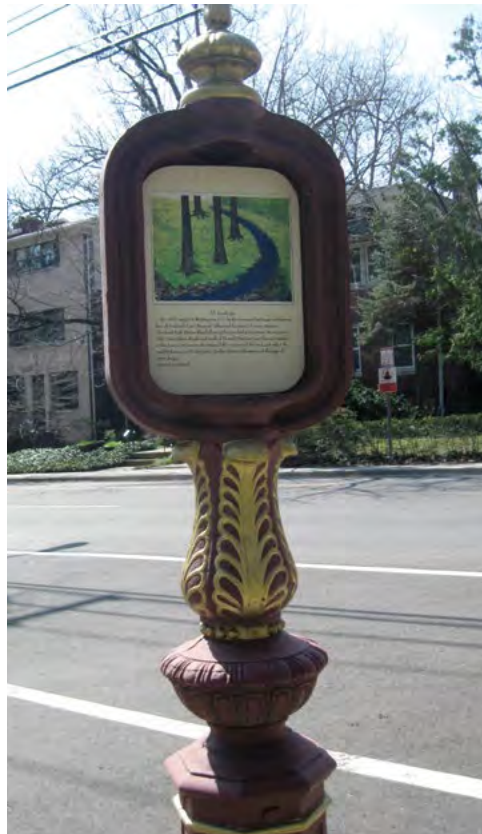
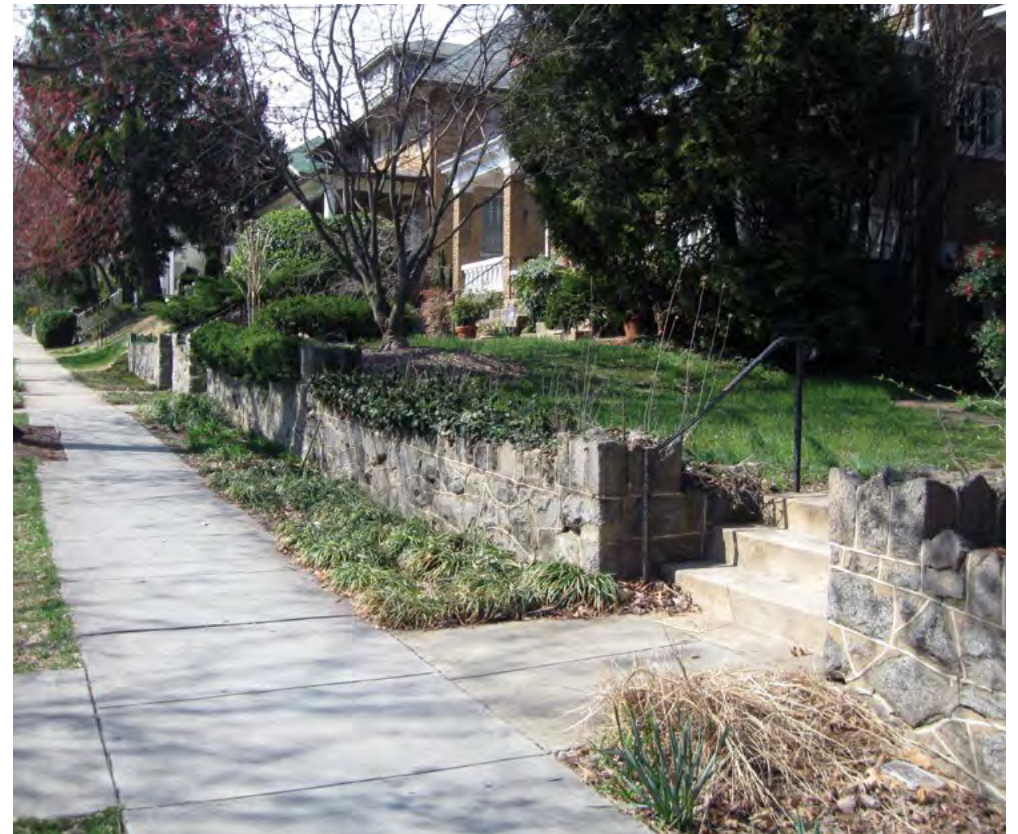
SETTING (DISTRICT / NEIGHBORHOOD)

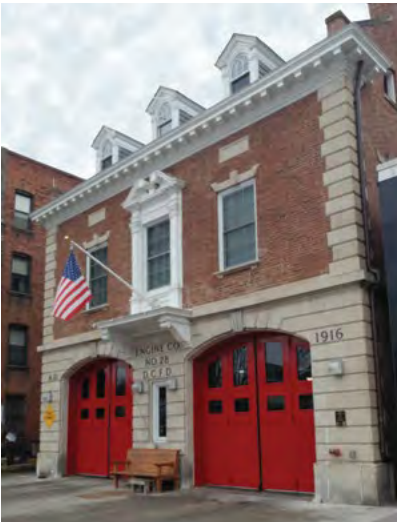
[56 a-b] In order to continue in its historic use, the door openings of this 1916 Colonial Revival-style fire station had to be widened to accommodate the larger size of modern fire trucks. Although this resulted in some change to the arched door surrounds, it is minimal and does not negatively impact the historic character of the building. (a) Above, before; Photo: Fire and Emergency Medical Services Department (FEMS), Washington, D.C.; below, after.

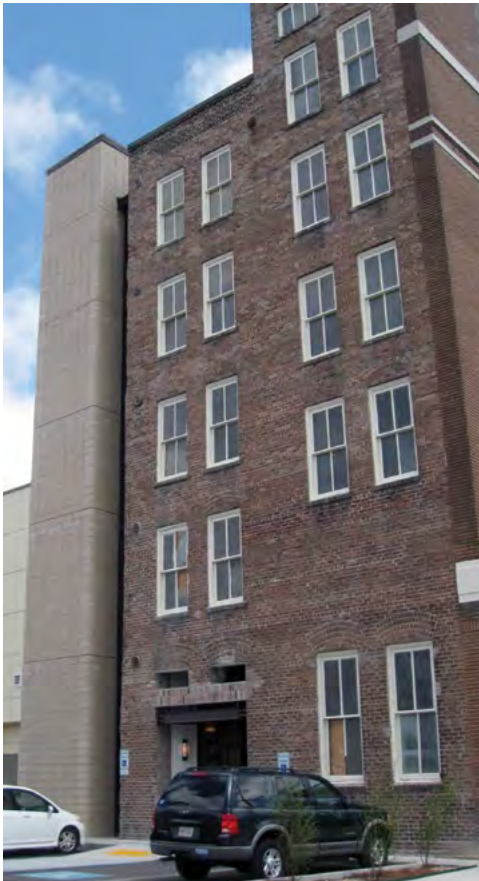
[62] The stair tower at the rear of this commercial building is a compatible new addition.

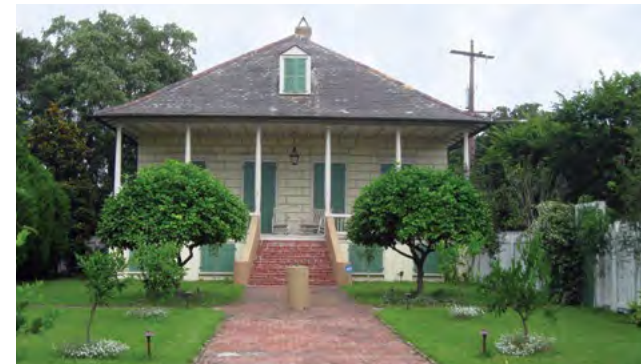
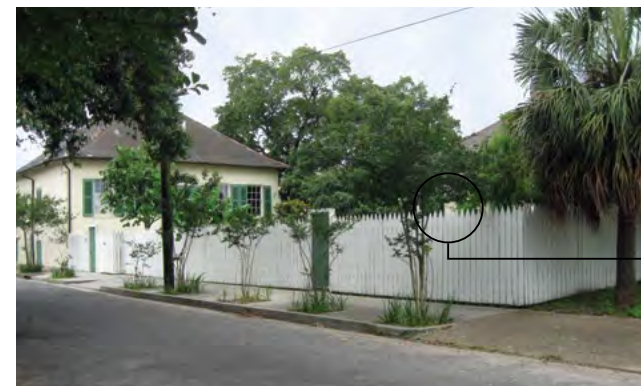
NEW EXTERIOR ADDITIONS TO HISTORIC BUILDINGS AND RELATED NEW CONSTRUCTION
