BASIN CHARACTERIZATION REPORT FOR THE SAN JACINTO – BRAZOS COASTAL BASIN FOR INDICATOR BACTERIA

Segments: 1101, 1102, 1103, 1104, 1105, 1107, 1108, 1109, 1110, 1111, 1113, 2424, 2425, 2427, 2431,
2432, 2433, 2434, 2436, 2437, 2438, 2439

Prepared for
Total Maximum Daily Load Program
Texas Commission on Environmental Quality
MC-203
P.O. Box 13087
Austin, Texas 78711-3087

Prepared by
Steven Johnston
Todd Running
Houston-Galveston Area Council
P.O. Box 22777
Houston, TX 77227-2777

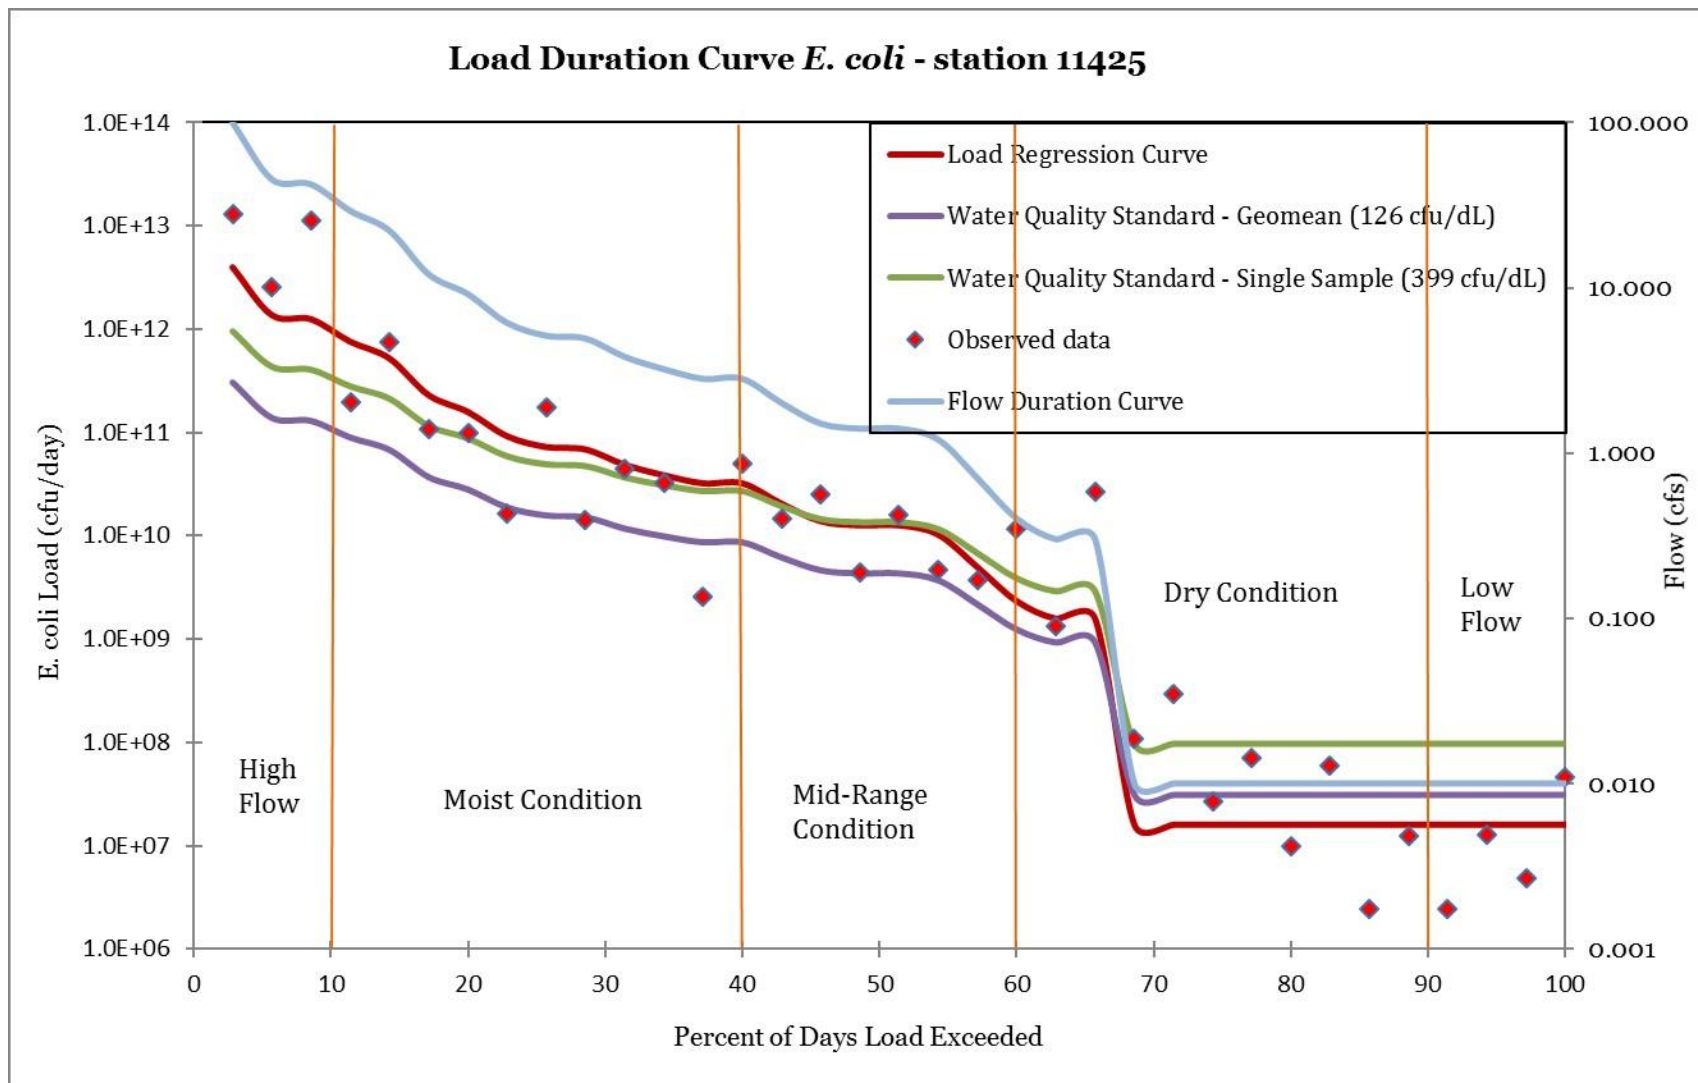
Load Duration Curve *E. coli* - station 11452

Available flow data and bacteria data were sufficient to complete an LDC for the two stations in this segment, 11425 and 11452, Cowart Creek and Clear Creek at Telephone Road respectively. Using the results of the LDC and the Days Since Last rain, factors affecting bacteria levels in this segment do not appear to strongly correlate with potential waste loads from WWTFs and OSSFs. Reading the LDC, the Load Regression Curve for bacteria data plotted for station 11425, exceeds the geomean standard and single grab standard approximately 40 percent of the time during wet to medium conditions. The bacteria regression curve falls below the Single Standard curve at 40 percent and falls below the Geomean Standard curve during drying conditions between 70 and 80% of days load exceeded. The LDC for station 11452 remains below the Single Standard and falls below the Geomean Standard curve at 50% of Days Load Exceeded. We expect wastewater treatment and OSSF to be contributing to bacteria exceedances when the LDC load regression curve is found above the standard during dry weather conditions, when nonpoint sources are little to non-existent. The Days Since Last Rain support this as the observed bacteria data straddles the standard evenly past 10 days since last rainfall.
